Conservation of  
**PULHAMITE ARTIFICIAL ROCKWORK**  
Ramsgate, Kent

**MADEIRA WALK**  
**STAGE TWO REPORT**

**Ramsgate Heritage Action Zone  
(HAZ) Partnership**

June 2020

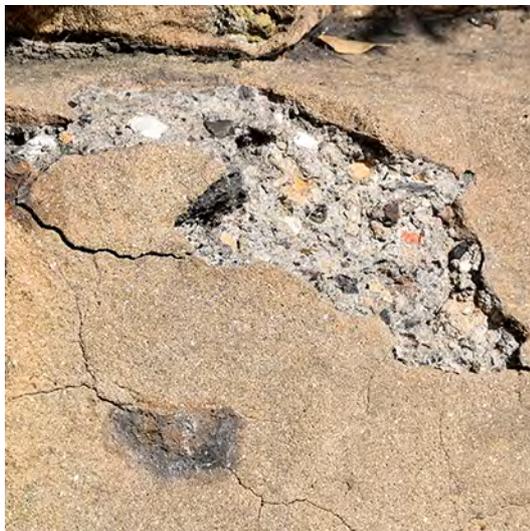
2.33: LOSS OF SURFACE EXPOSES  
ROUGH CONCRETE BACKING

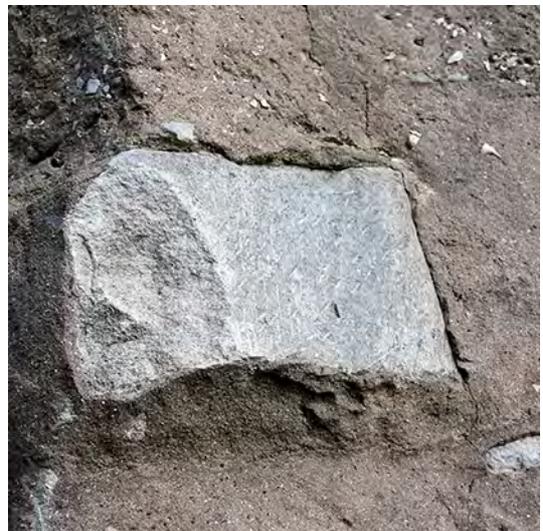
2.34: GRANITE WITHIN BACKING REVEALED  
BY LOSS OF SURFACE

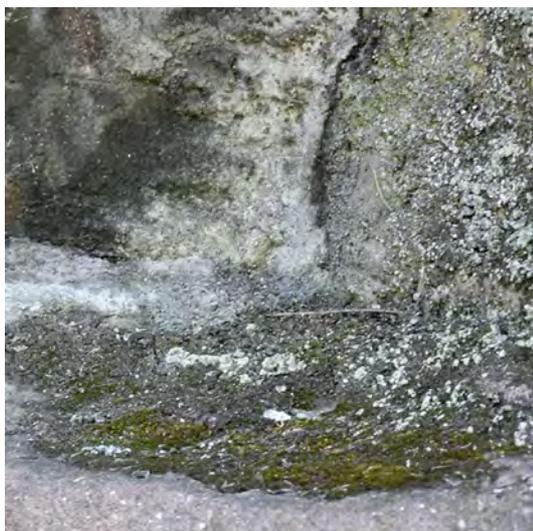
5.01: MOSS ON SKY FACING SURFACE (S06)

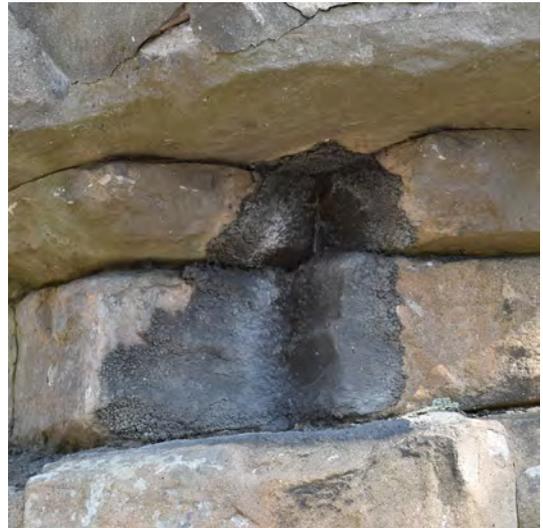
5.04: SULFATE CRUST (S02)

the first stage of this process. While the crusts (which are almost certainly ‘cross-liked’ with the render coating and hence hard to remove) and blooms may eventually play a role in surface erosion, they are in the main benign and should be accepted as part of the historic aging of the rockwork. The only exception would be where cleaning is necessary to effect repairs, noting that within the grotto recesses, tunnel and passage airborne dirt and sulfation can be difficult to distinguish.

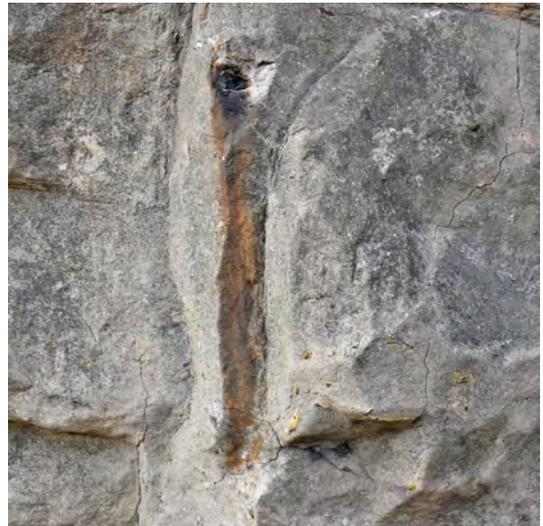
- **Metal staining** (runoff) was in a few instances associated with the embedded remnants of historic ironwork (e.g. N05, N07 & N08).

5.06: IRON STAINING (N07)

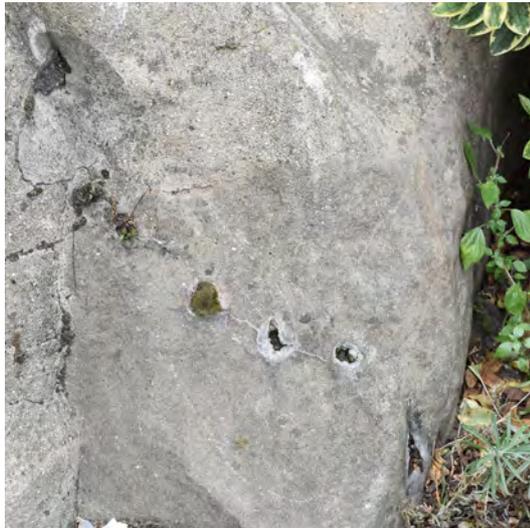
5.07: MINOR LOSS (N01)

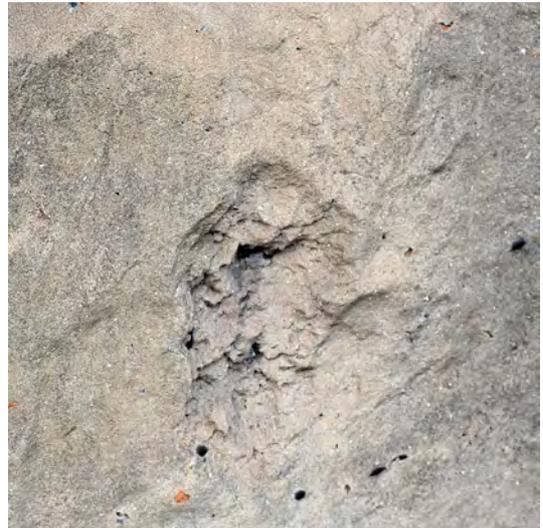
5.08: DEEP SCOURING (N08)

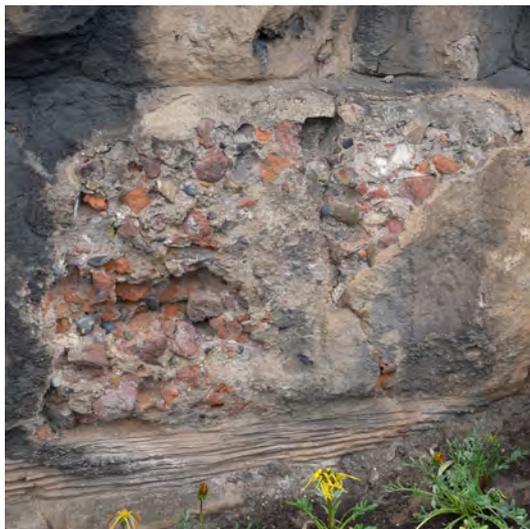
- 5.3.03 Two of the observed instances of more widespread pitting, hollowness, granulation and surface loss (N09 & N11) appear to relate to orientation as well as salt build-up having reached the point where the render coating has been weakened by chemical action (refer 7.3.03/05 of the Overview: Stage One Report). Here, the light-coloured PAR — which is low down and hence relatively sheltered, i.e. not washed, similar to if it were beneath and overhang — faces the Harbour and hence is exposed to a prevailing wind that is laden with high levels of salt (sea spray) as well as fine grains of sand whipped-up from nearby beaches. Salt levels and abrasion will therefore be intensified making detached or friable surfaces more prone to erosion and loss. Hence the ‘preferential’ weathering.

5.11: SURFACE LOSS DUE — PREFERENTIAL WEATHERING DUE TO ORIENTATION (N09)

- 5.3.07 Renewal and restoration of the hollowed, granulated and lost areas of surface as considered in 5.3.03 and 5.3.05 is also a possibility. However, as regards N09 and N11, the high exposure to salts and southwest orientation — key agents of decay — cannot be changed, the deterioration would in time be repeated; likewise the sometimes deteriorated chalk block backing to S01, S02, etc. In which context it would be prudent to continue to monitor and — in line with the philosophy set out in 5.1.03 — accept localised surface loss as part of the historic ‘weathering’ of the PAR, subject to review as part of the next quinquennial (five-yearly) survey update.

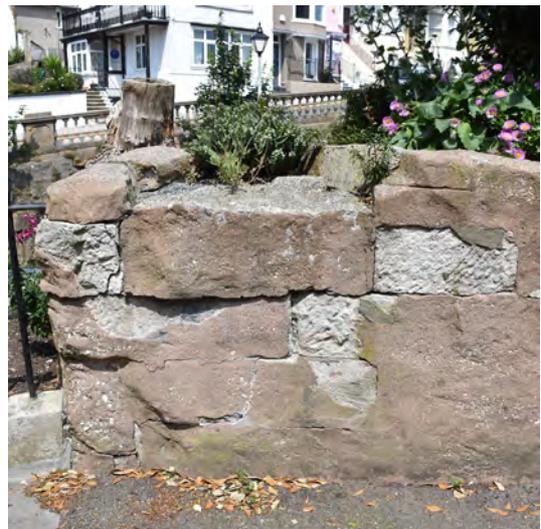
- 5.3.04 The influence of orientation is also evident on north-facing areas of surface loss (S01, S02, S05, S09, S10 & S11) as well as two south facing — albeit often shadowed — instances (S02 & S08C). Here, the surface has clearly ‘sheared’, indicating that while chemical action might play a part (initial cracking ‘opening-up’ surfaces) the principal cause of loss is likely to be frost action due to a higher exposure to wetting and low temperatures combined with reduced exposure to the warming effect of the sun. The apparently frost-shattered backings in some of these areas (refer 5.4.01) adds weight to this argument. Poor keying may also be a factor (applies also to granite).

5.12: SURFACE LOSS — SHEARING FROM CHALK BLOCKS DUE TO FROST (S01)

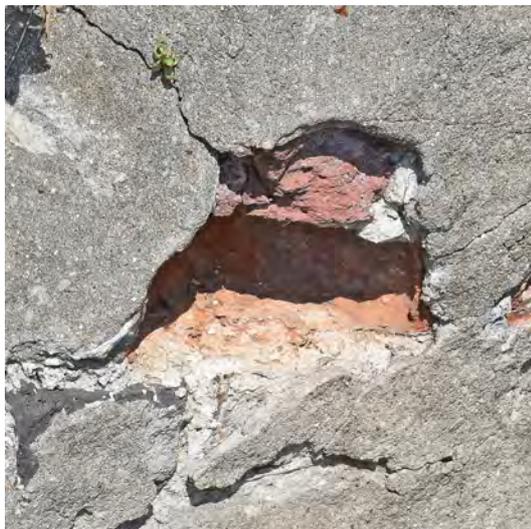
5.13: LOSS OF SURFACE LEAVING COATING VULNERABLE TO WATER (N37)

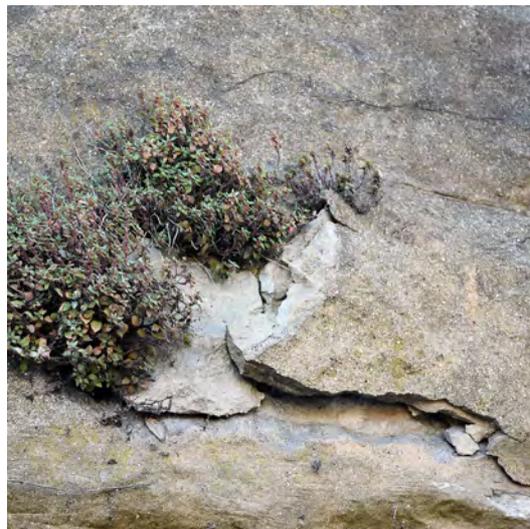
5.14: PARTIALLY DETACHED AREA OF COATING AT HIGH LEVEL (S09)

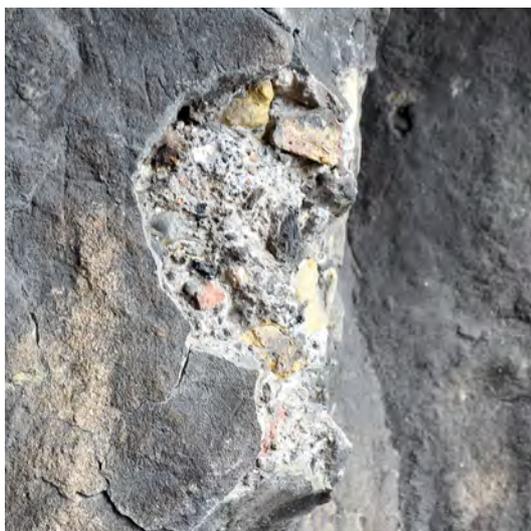
5.15: IMPACT DAMAGE (N16)

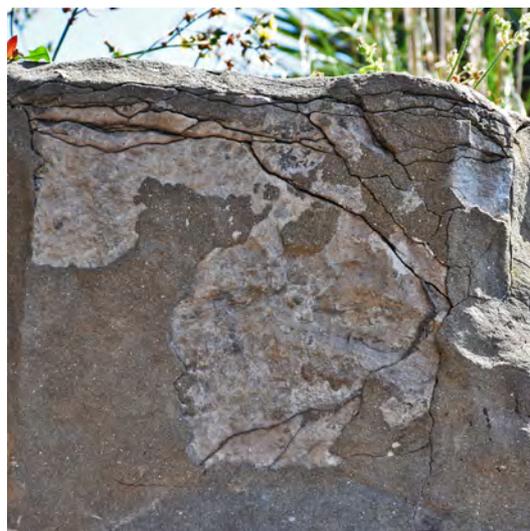
5.16: FROST DAMAGED CHALK (S08C)

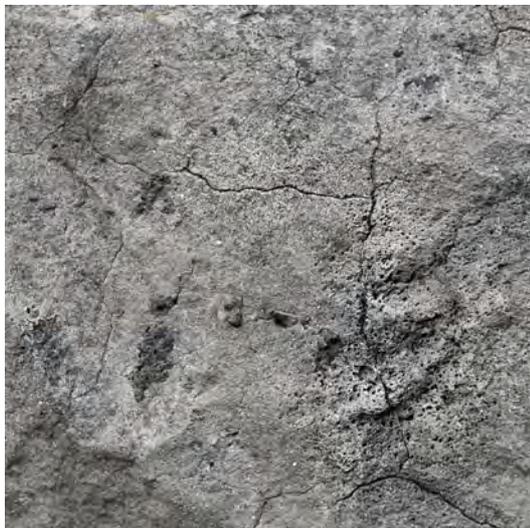
5.17: FINE SURFACE CRACKING (N03)

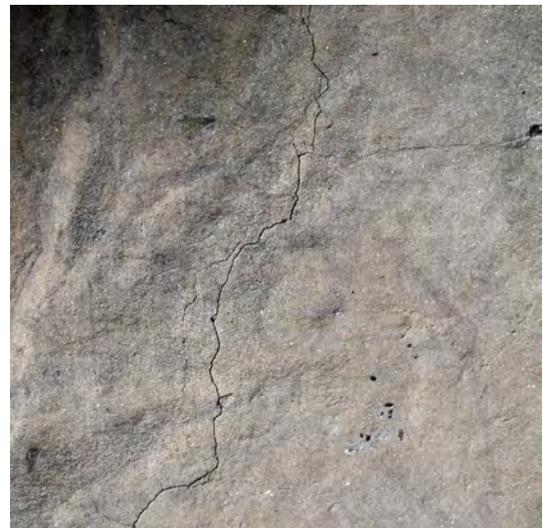
5.18: HAIRLINE FRACTURE (N14)

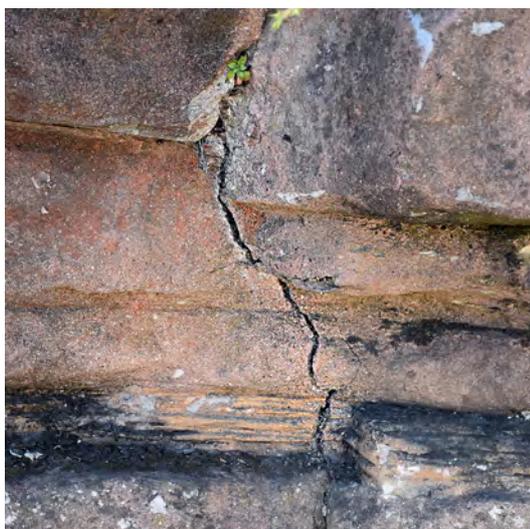
5.19: MAJOR FRACTURE (S07)

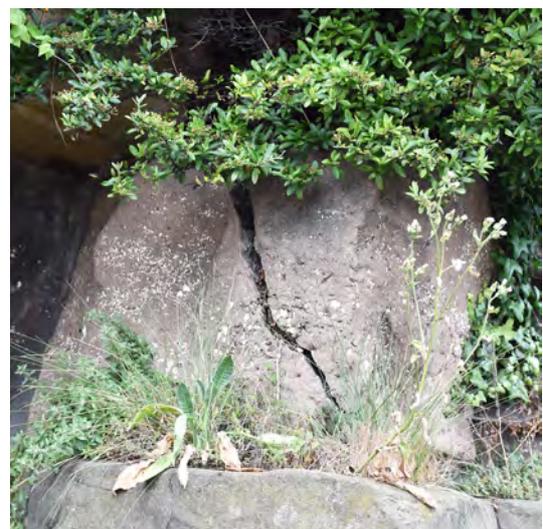
5.20: FRACTURE & DISPLACEMENT (N19)

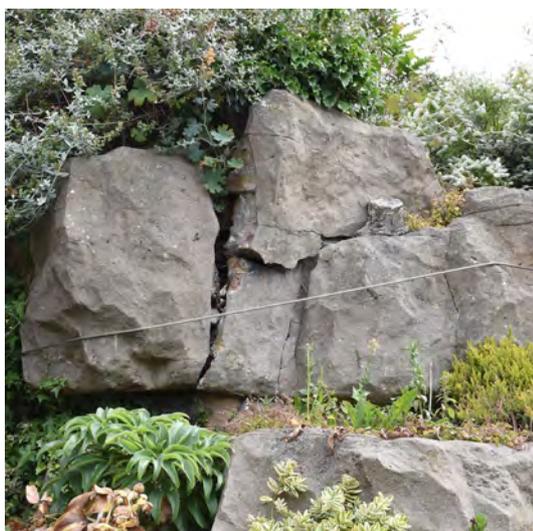
5.21: FRACTURE &amp; COLLAPSE (N29)

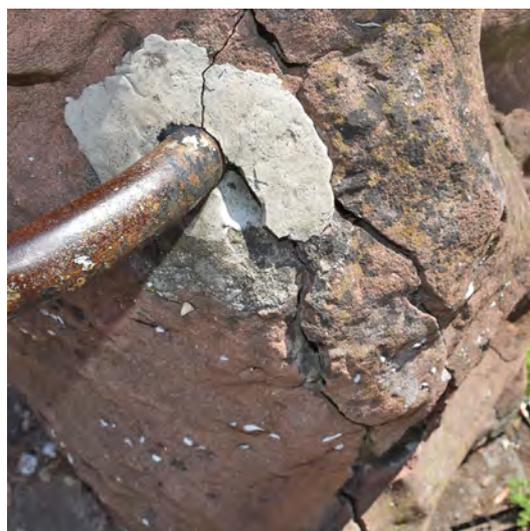
5.22: FRACTURE — EMBEDDED IRON (S04)
