Conservation of  
**PULHAMITE ARTIFICIAL ROCKWORK**  
Ramsgate, Kent

**WINTERSTOKE GARDENS**  
**STAGE TWO REPORT**

**Ramsgate Heritage Action Zone  
(HAZ) Partnership**

June 2020

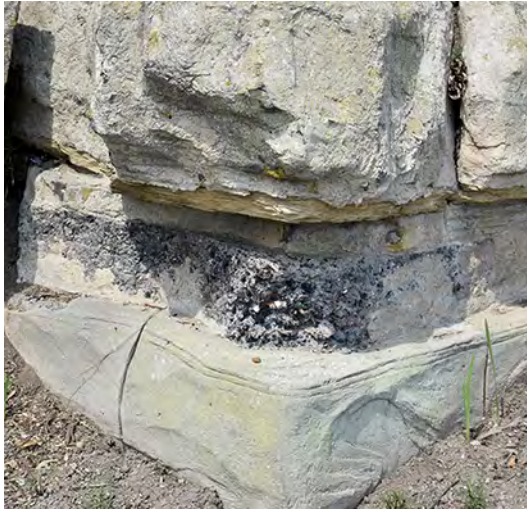
2.15: CONCRETE EXPOSED BY EROSION

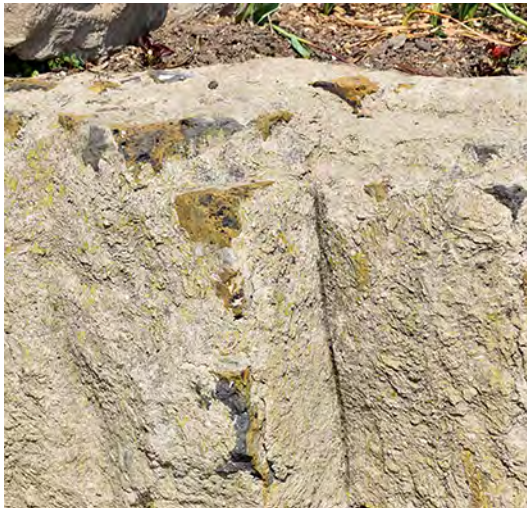
2.17: EROSION EXPOSES BRICKWORK

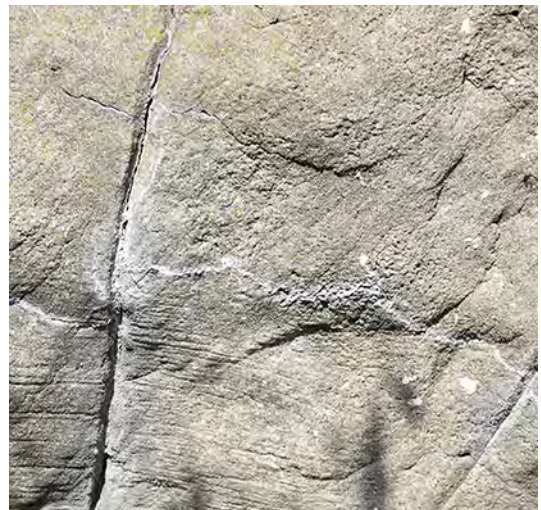
2.20 VEINS SUGGEST SULFATE ATTACK

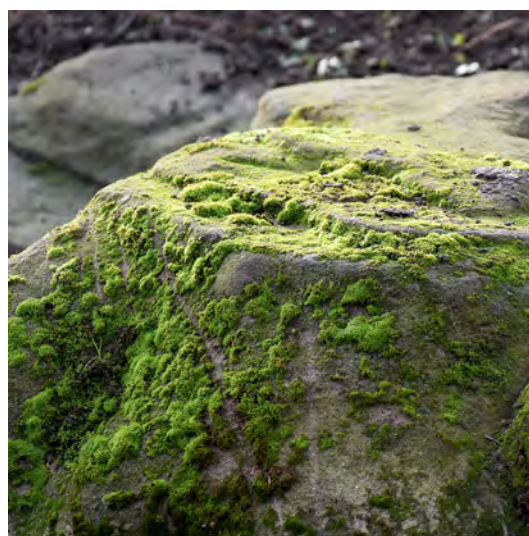
5.02: BUILD-UP OF MOSS (D12)

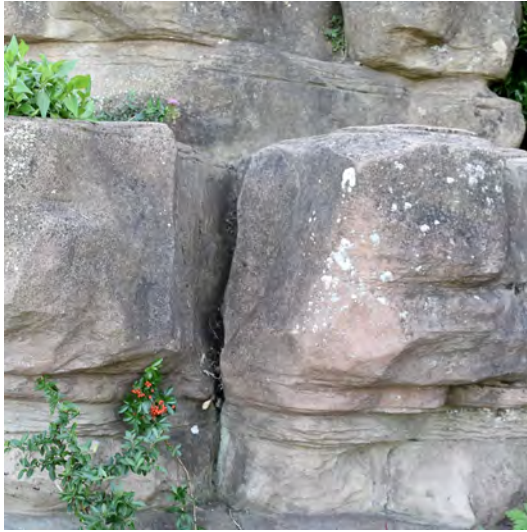
5.03: AIRBORNE DIRT— NO LICHENS (B19)

- 5.2.02 Instances of mosses notwithstanding; lichens and the relative lack of airborne dirt are indicative of the good condition of the PAR coating generally, the result of it being removed from busy roads and historically polluted urban areas, along with a high degree of exposure to driving rain. i.e. rain washing.

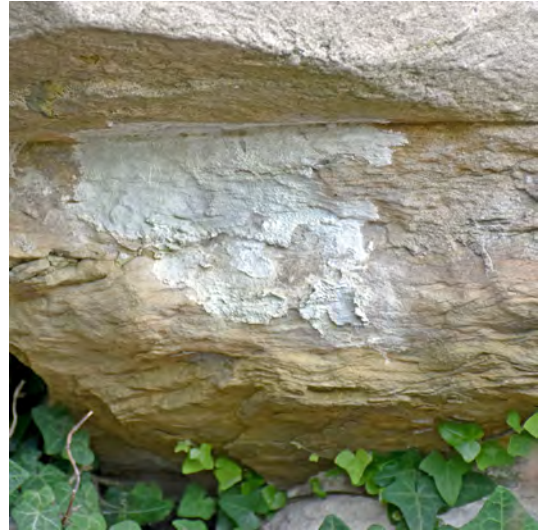
- **Airborne dirt** was almost universally present where lichens are absent, albeit soiling is in the main light to imperceptible.
- **Surface efflorescence** beneath overhangs and in other sheltered areas was observed generally, and in some instances had converted to a **sulfate** crust albeit — due to an historic lack of airborne pollution — these are generally white only tending sometimes to a light grey.

5.04: SURFACE EFFLORESCENCE (C11)

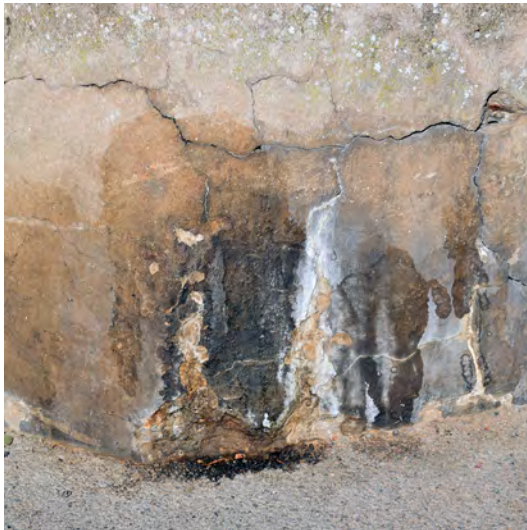
5.05: REPEATED DOG URINATION (C06B)

threatening surface damage, notwithstanding the smell and possible health implications; control needs to be considered.

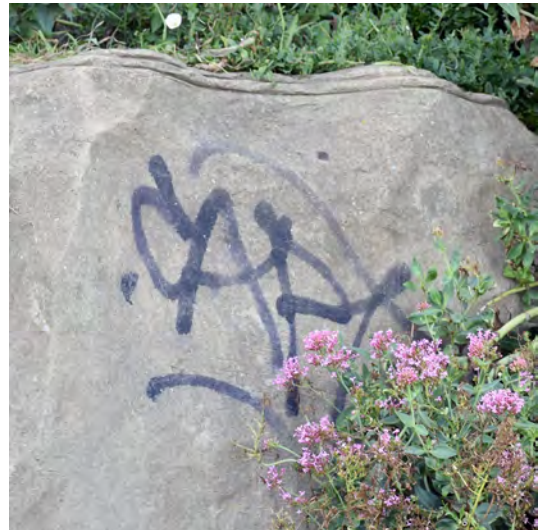
- **Graffiti** was light and mainly comprised chalk, though spray paint was in three isolated cases (C01, C11 & C13) notably present and in three more visible but faded (B01, C18 & C21).

5.06: GRAFFITI — SPRAY PAINT (C11)

- 5.2.04 The relative absence of graffiti is perhaps due to the smooth walls of the Sun Shelter offering a more appealing canvas, noting that even the three most notable examples are not offensive or visually intrusive; and given that graffiti removal (refer D3.08 of Appendix D) can itself be highly damaging are best left to fade. Likewise chalk which if rubbed too early can permanently stain and will eventually wash away, albeit light sponging may be employed in sheltered areas.

- 5.2.05 Soiling and discolouration of the Winterstoke Gardens rockwork is a minor issue and there is no pressing need for cleaning, notwithstanding graffiti control being an essential part of routine maintenance (refer 6.3.06 & 6.3.07). Nonetheless, mosses indicate damp and hence should be removed to enable the condition of the rockwork below to be examined.
- 5.2.06 Preventing dogs from urinating on the PAR is a difficult matter, one that can probably only be controlled via a programme of public information and education, albeit the possibility of repellents could be explored. Long term, reinstatement of the low metal fences in front of the rockwork (refer 4.1.04) would in part alleviate the problem.

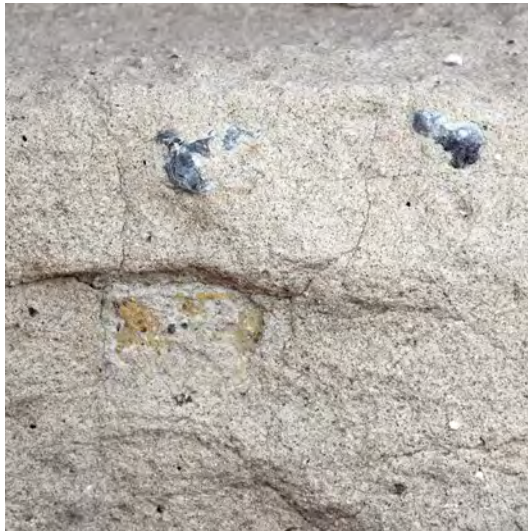
5.07: LIGHT EROSION & MINOR LOSS (C12)

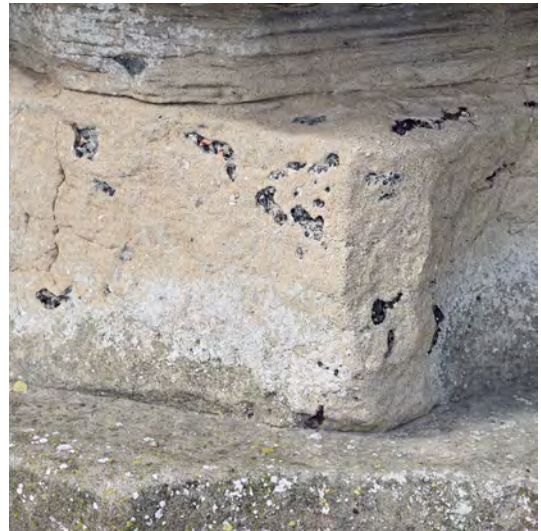
- Areas of more intensive pitting mixed with hollowness and granulation leading to small areas of surface loss were noted (B03, B05, B13A, B14, C08, C16 & D03B) with total loss exposing the concrete backing in zones B02A, D02 and D03A

5.08: PITTING & GRANULATION (B05)

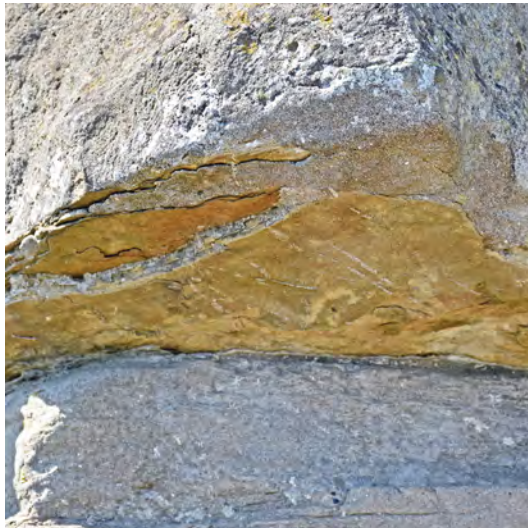
5.09: UNDERSIDE LOSS OF COATING (B13B)

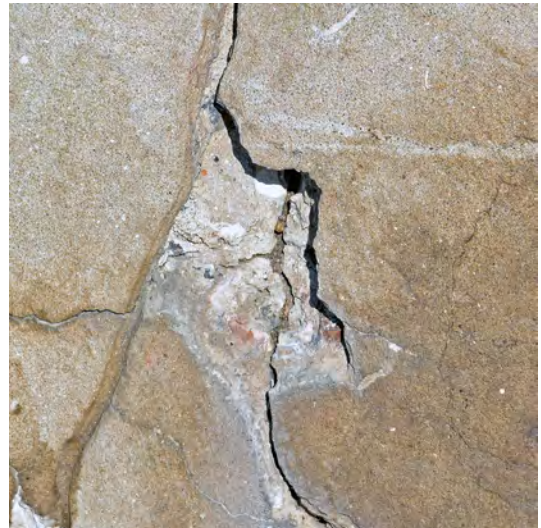
5.10: SURFACE LOSS & FRACTURE (C06A)

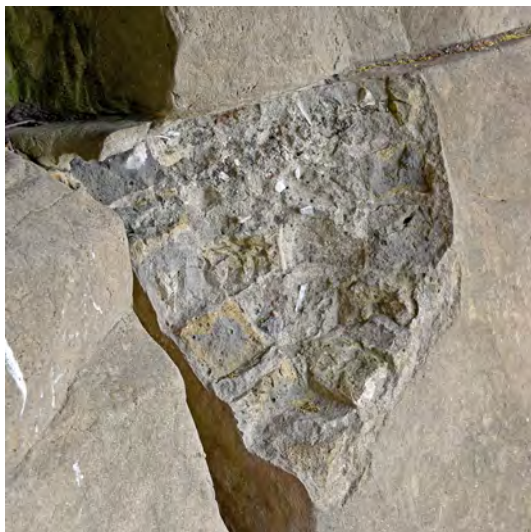
5.11: LOSS OF SURFACE LEAVING COATING & BACKING VULNERABLE TO WATER (C01)

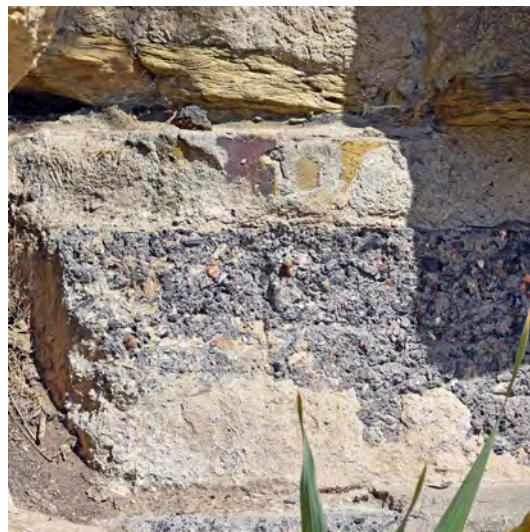
- 5.3.03 As with surface efflorescence and sulfate crusts (refer 5.2.03), the observed instances of more widespread pitting, hollowness, granulation and surface loss (B02A, B03, B05,

B13A, B14, C08, C16, D02, D03A & D03B) are in the main beneath overhangs and in sheltered areas, and where the build-up of salts has reached the point where the render coating has been weakened by chemical action (refer 7.3.03/05 of the Overview: Stage One Report). Orientation is also a factor. All of the most seriously decayed (or lost) areas of surface face southwest and hence are directly exposed to the prevailing wind which — coming in off the sea and nearby beaches — will be laden with high levels of salt (sea spray) and fine grains of sand. Salt levels and abrasion will therefore be intensified making detached or friable surfaces more prone to deep erosion and loss. Hence the ‘preferential’ weathering of sheltered areas or southwest facing coating. The influence of orientation is also evident on some more exposed areas of PAR (e.g. A02, A05, A06A, C12 & E02A), where — as already noted in 5.3.01 — scouring (erosion) is deeper than the norm.

5.12: LOSS OF COATING DUE TO SALTS & PREFERENTIAL WEATHERING (D02)

- 5.3.07 Renewal and restoration of the hollowed, granulated and lost areas of surface as considered in 5.3.04 is also a possibility. However, as the high exposure to salts and southwest orientation — key agents of decay — cannot be changed, the deterioration would in time be repeated unless a sulfate-resisting cement were used for the new coating; which raises issues over the authenticity of historic fabric, although any decision on repair must stem from further investigation (D1.01 of Appendix D). In which context it would be prudent to continue to monitor and — in line with the philosophy set out in 5.1.03 — accept localised surface loss as part of the historic ‘weathering’ of the PAR, subject to review as part of the next quinquennial (five-yearly) survey update.

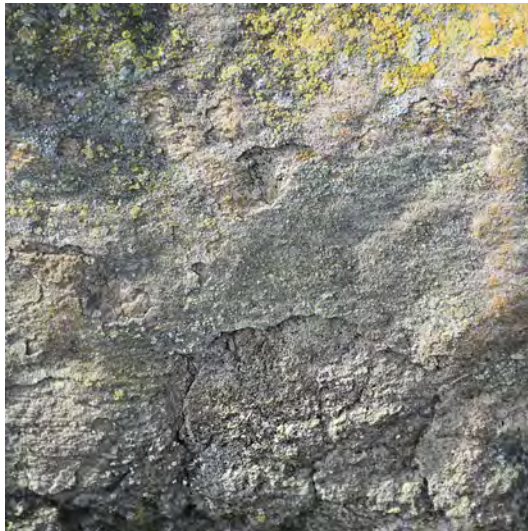
5.13: SCOURING DUE TO ORIENTATION (A05)

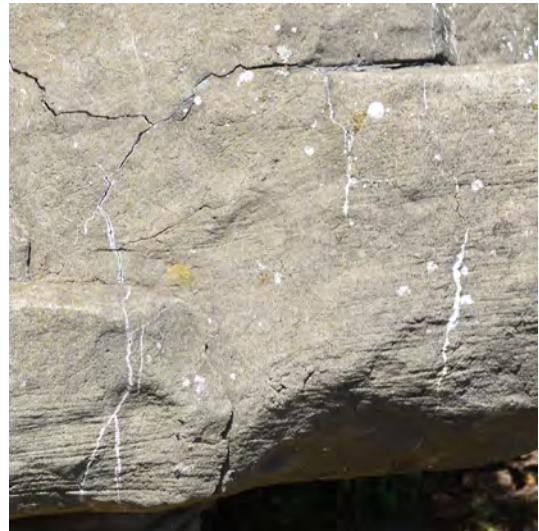
5.14: CRYSTALLINE (SULFATE) VIENS (B12)

- Veins of sulfate attack (refer 5.3.04) should be monitored as part of the inspection regime outlined in 6.3.03.
  - Hollowed or lost surfaces adjacent fractures should be repaired in conjunction with fracture repair (refer 5.5.04): sound surfaces can be consolidated with lost areas repaired to match the original.

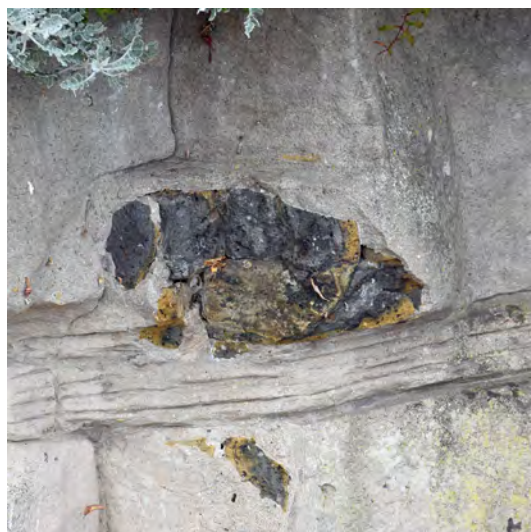
- 5.4.01 A few instances of impact damage to backings (that also affect coatings — refer 5.3.02) were observed: A12B, B01, B08, B20, C05 and D08. The decay (powdering and delamination) of stone slab overhangs was also generally evident, most notably in zones B05, C09, C10, C12, C16, C18 to 20, D02, D03A, D05 and D06. Making good impact damage will by necessity be a precursor to the repair of the vulnerable areas as noted in 5.3.06. As in the case of coatings (refer 5.3.08), underside decay of stonework is best accepted, though ongoing loss should be monitored and if necessary pinning or consolidation might be considered. Defects in backings as a result of fracture and displacement are covered by 5.5.01 to 5.5.04 below.

5.15: DAMAGE TO COATING & BACKING DUE TO VEHICULAR IMPACT (B08)

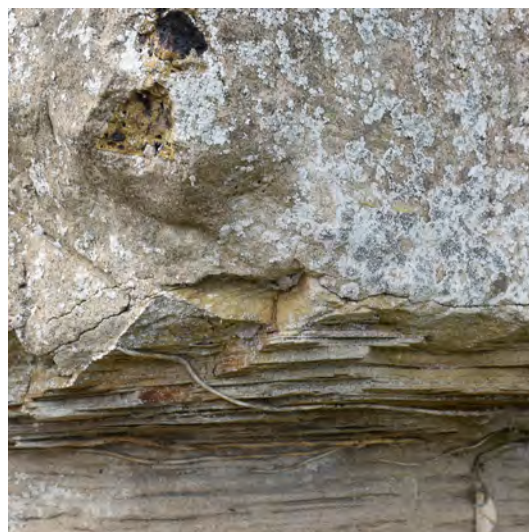
5.16: DELAMINATION TO UNDERSIDE OF STONE SLAB OVERHANG (B05)

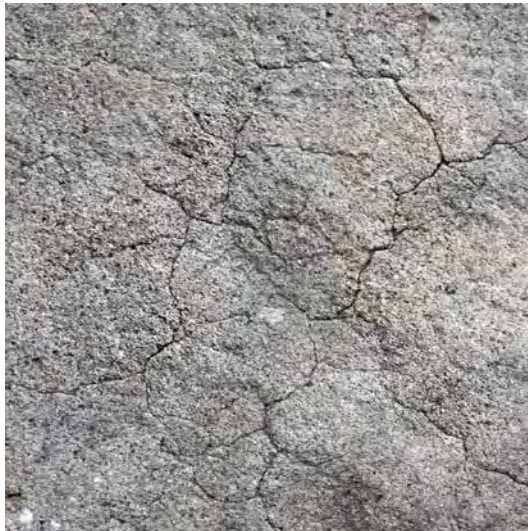
- 5.5.01 Fine surface cracking is almost universally present, sometimes manifest as isolated occurrences but generally evident as crazing; most of the cracking is weathered and overlain with lichens or dirt. Although less extensive, fractures (cracks that penetrate backings — refer 7.5.03 of the Overview: Stage One Report) were present across much of the rockwork, though with a greater concentration (about 70%) in the central sections framing the sun shelter:

5.17: FINE SURFACE CRACKING (A16)

- 5.5.02 Weathering and dirt means that much of the fine cracking is historic and, given that it is generally sound and does not appear to be worsening, probably dates back to soon after the application of the coating, i.e. the majority is due to overworking or initial drying shrinkage (refer 7.5.02 of the Overview: Stage One Report) and does not present a problem. Some of the coarser cracking is associated with friable surfaces and deterioration due to chemical agents (refer 5.3.03).

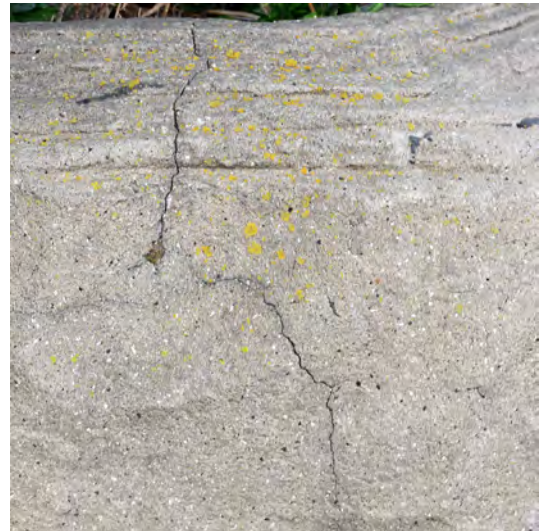
- Significant hairline fractures up 1–3 mm in width were present in zones: A13 (2 no), A14A (6 no), A15 (2 no), A16 (2 no), B01, B02A, B04, B05 (2 no), B07,

5.18: HAIRLINE FRACTURE (A14A)

- 5.5.04 Although often highly visible and in some cases involving considerable displacement, there are no instances where cracks or fractures are of immediate (short term) need of repair PROVIDED VEGETATION IS BROUGHT UNDER CONTROL AND MANAGED BY WAY OF ROUTINE MAINTENANCE, and that monitoring is an integral part of the inspection regime described over paragraphs 6.3.02 to 6.3.05. Following-on, the repair of all but the most minor fractures should — by 'closing' the rockwork to the ingress of self-sown vegetation — arrest the ongoing penetration of roots and woody stems:
- **Hairline fractures** can in the main be left and monitored albeit micro-grouting would be a good way of filling the widest (up to 2 mm).
  - Depending on width, **major fractures** should be repaired by grouting or filling with a weak, lime mortar. All filling should be set back so as to avoid the need to

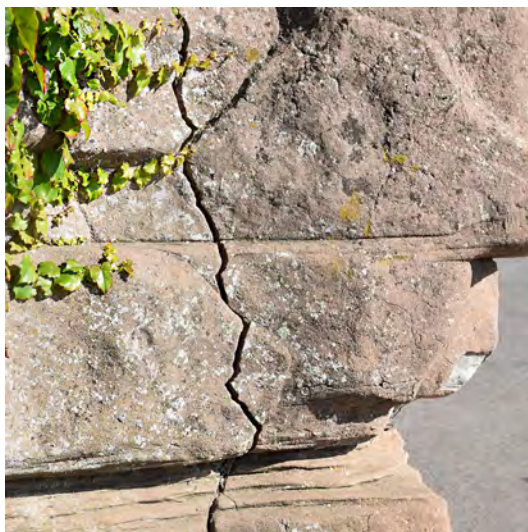
5.19: MAJOR FRACTURE (C06A)

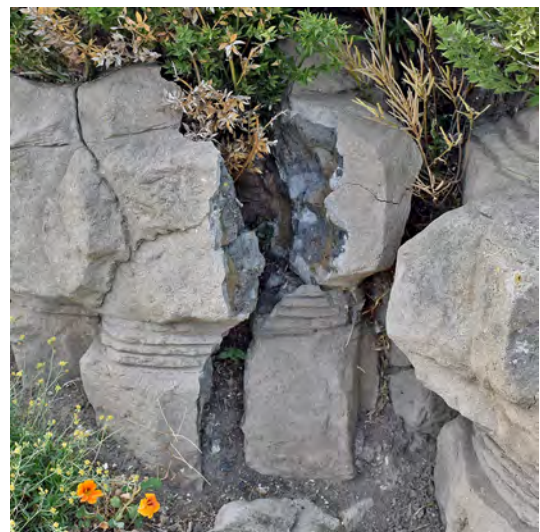
- Major fractures — mainly vertical or near vertical but with associated diagonal and horizontal components — were present in zones: A10, A14A, B07 to B13A, B14 to B16, B18 to B20, C01 to C04, C06A, C07, C13, C14, C18 to C21, D01, D05, E02C, E03 and E04.
- Wholesale displacement involving fractures was present in zones: A08, A10, A13, B10, C01, C07 and D02.

5.20: FRACTURE & DISPLACEMENT (A10)

- Where fractures have led to wholesale **displacement**, the rockwork will need to be recorded, carefully taken down and rebuilt with original fabric eased back into position and where necessary surfaces skilfully repaired to match existing.

Filling and rebuilding will in all cases require localised clearance of all vegetation and soil, and — in order to ‘stitch’ historic fabric — the introduction of short lengths of helical, stainless steel bar to the ‘earth’ side of the fracture (refer Appendix D5.06).

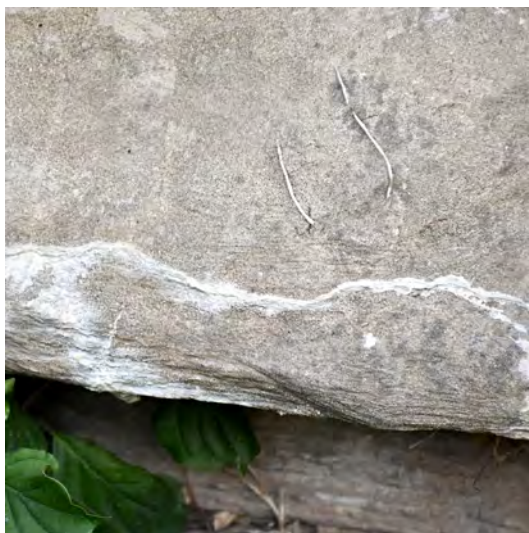
- 5.5.03 While some hairline fractures — mainly horizontal and especially near the bases of plant pockets — are likely to a consequence of the expansion of crystalline veins, i.e. sulfate attack (refer 5.3.04), the majority of fractures and associated displacement are due to unmanaged, woody vegetation. This is the greatest threat to the ongoing conservation of the Winterstoke Gardens PAR. Not just tree or shrub boles and root systems which have outgrown plant pockets, but also ivy and other invasive plants that have self-sown in fissures and sometimes fake cracks.

5.21: HORIZONTAL V SULFATE ATTACK AT BASE OF PLANT POCKET(C15)

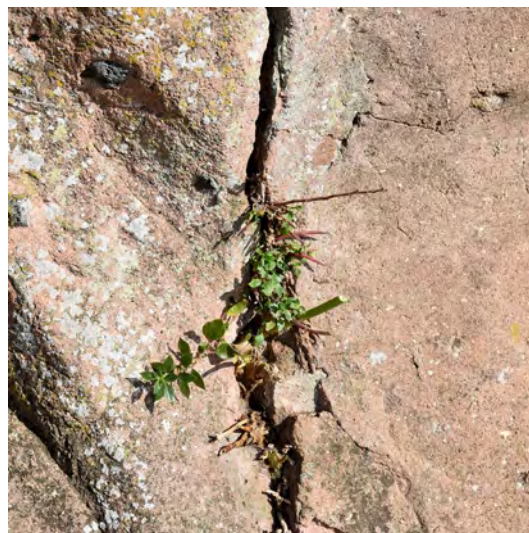
5.22: WOODY VEGETATION SELF-SOWN IN OPEN FRACTURE (B15)
