Conservation of
PULHAMITE ARTIFICIAL ROCKWORK
Ramsgate, Kent

EAST CLIFF CHINE
STAGE TWO REPORT

**Ramsgate Heritage Action Zone
(HAZ) Partnership**

June 2020

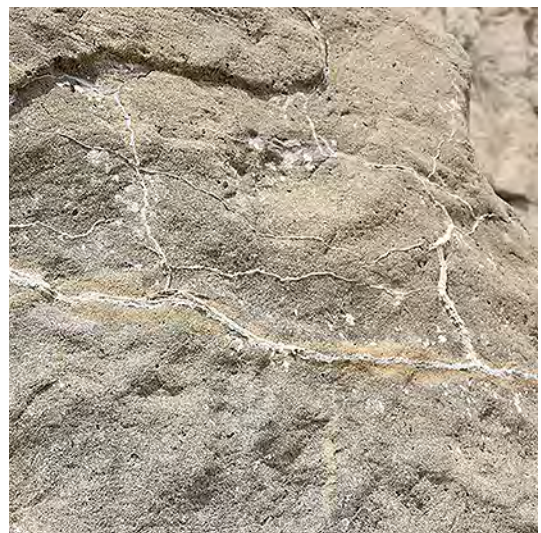
2.26: VEINS SUGGEST SULFATE ATTACK

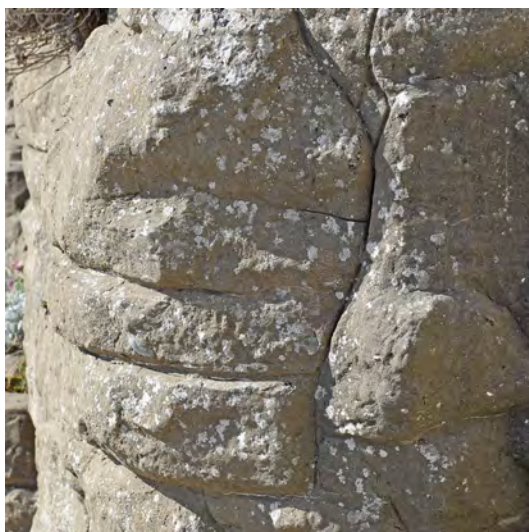
5.01: LICHENS IN A LOCATION SHELTERED FROM THE PREVAILING WIND (A27C)

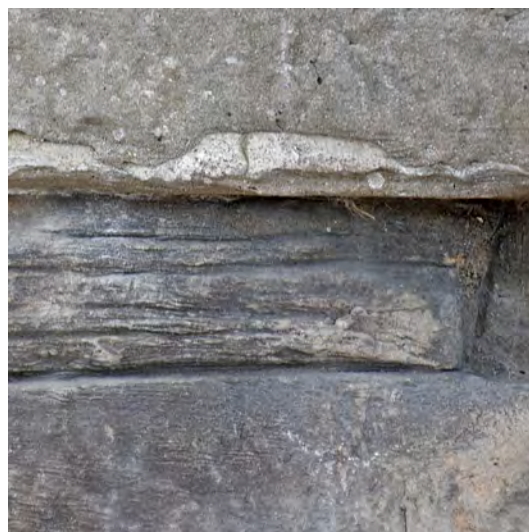
5.02: MINIMAL RAIN WASHING PERMITS BUILD-UP OF AIRBORNE DIRT (A10)

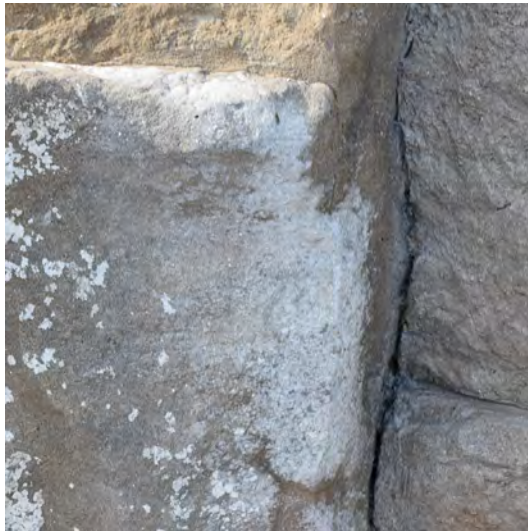
5.03: EFFLORESCENCE + LICHENS (B05)

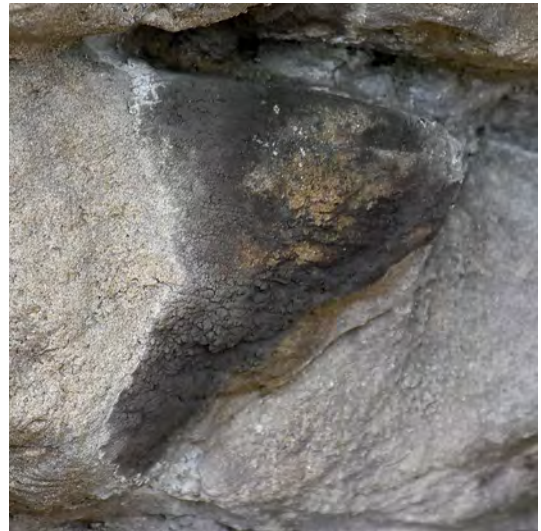
5.04: SULFATE CRUST (B01)

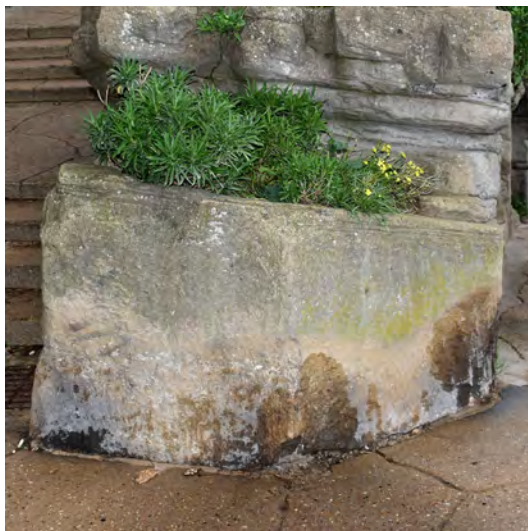
5.05: IMPACT OF CANINE URINE (B01)

threatening surface damage, aside from the unpleasant smell and possible health implications; control needs to be considered.

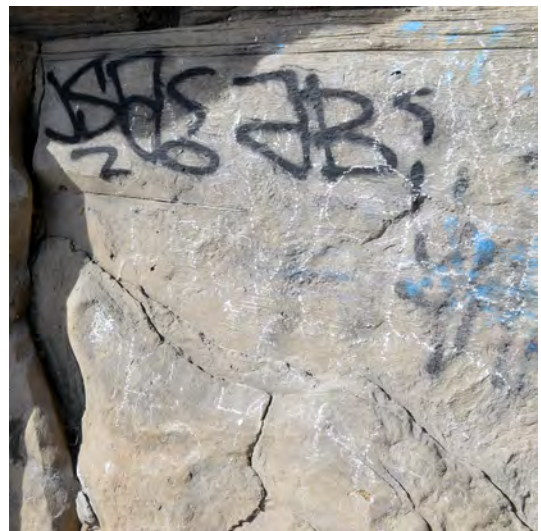
- **Graffiti** was extensive. Chalk was the most common marker, though spray paint — often faded — was also present, the most visible instances being in zones A20, A21, A27C, A35, B04, B05, B07–B10, B22, C03, C05 & C11. Felt tip pen were also noted (B07 & C09). Most graffiti was at low level save where the ‘artist’ had bravely scaled the rockwork to leave their ‘tag’ (e.g. B22).

5.06: CHALK & SPRAY PAINT GRAFFITI (B10)

- 5.2.04 Graffiti in and around shelters — especially those with seats — and at low level generally, is almost impossible to control though chalk that is exposed to the rain will eventually wash away; while rubbing chalk too early can lead to permanent staining, light sponging may be employed in sheltered areas. Although no instances of spray painting were offensive and most were unobtrusive, removal of the most prominent and accessible examples (A20, A21, B04, B05, B07–B10, C03, C05 & C11) would be prudent, lest others should be tempted to add their tag. However, graffiti removal (refer D3.08 of Appendix D) can be damaging; old spray paint is best left to fade.

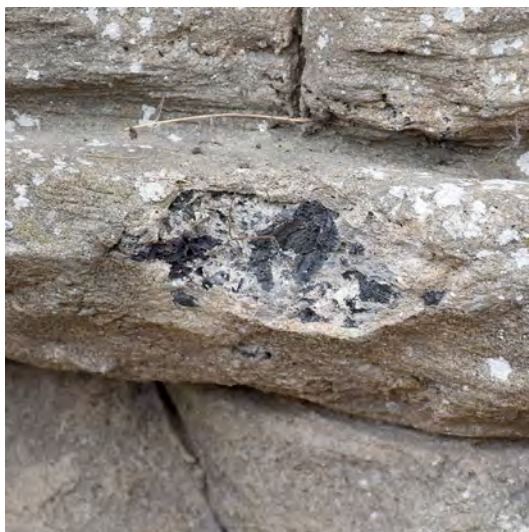
5.07: TYPICAL EXAMPLE OF MINOR LOSS OF PAR COATING (B01)

- 5.3.05 The general pitting and loss of rendered surfaces is a minor issue that warrants no more than regular inspection (refer 6.3.02 to 6.3.05), save perhaps occasionally work to mitigate the few exposed edges and backings that might be vulnerable to further water decay due to water penetration. Dressing (careful trimming) the render to remove loose material and water traps would be a practical short to medium-term option. Beyond which, the skilfully-matched restoration of missing areas of coating would be the preferred method of repair, albeit the economics of working at height (refer 5.3.02) would suggest that any necessary works to surfaces are combined with repairs to fractures as scheduled in 6.4.02; sound surfaces can be re-attached by micro-grouting and maybe pinning with lost areas repaired to match the original.

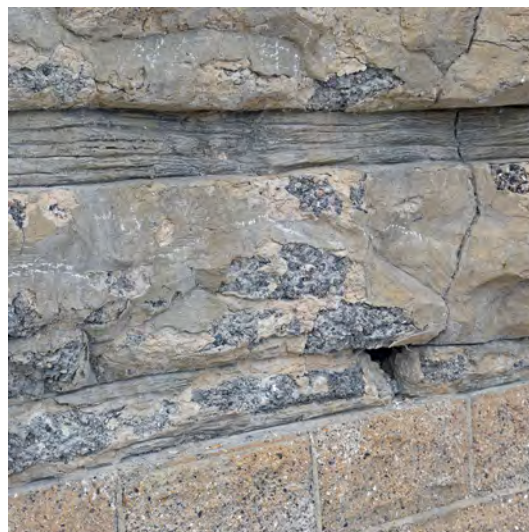
5.08: EXTENSIVE LOSS OF SURFACE WITH HOLLOWNESS & GRANULATION (A03)

- 5.3.03 As with surface effloresce and sulfate crusts (refer 5.2.03), the observed instances of more widespread pitting, hollowness, granulation and surface loss (A01 to A04, A06, A08 & A09, B03, B09, C09 and C13) are all in areas where the build–up of salts has reached the point where the render coating has been weakened by chemical action (refer 7.3.03/05 of the Overview: Stage One Report). In the case of the East Cliff Chine, orientation and elevation are the key factors. All of the most seriously decayed (or lost) areas of surface face southwest and are low down. They are directly exposed to the prevailing wind which — coming in off the sea and nearby beaches — will often be laden with high levels of salt (sea spray) and fine grains of sand; add to which they

are also subject to salt-laden run-off from the high rockwork faces above. Salt levels and abrasion will therefore be intensified making detached or friable surfaces more prone to deep erosion and loss. Hence the extensive 'preferential' weathering of the southwest facing coating in zones A03 and A04. The influence of the plan of the Chine (refer 2.2.01) on the weathering of the PAR is subtle — the condition of its surfaces is notably improved as the cliff face curves north, away from the prevailing wind. Salts will also have exacerbated the loss of surface from the undersides of overhangs.

- 5.3.06 Renewal and restoration of the hollowed, granulated and lost areas of surface as considered in 5.3.03 is also a possibility. However, as the high exposure to salts and southwest orientation — key agents of decay — cannot be changed, the deterioration would in time be repeated unless a sulfate-resisting cement were used for the new coating; which raises issues over the authenticity of historic fabric, although any decision on repair must stem from further investigation (D1.01 of Appendix D). There is also a need to consider the interaction between coatings and the concrete block backing, the latter quite possibly being more of a reservoir of salts that would be the case with brick or stone. In which context it would be prudent to continue to monitor and — in line with the philosophy set out in 5.1.03 — accept the localised surface loss evident in zones A01 to A04, etc. as part of the historic 'weathering' of the PAR, subject to review as part of the next quinquennial (five-yearly) survey update.

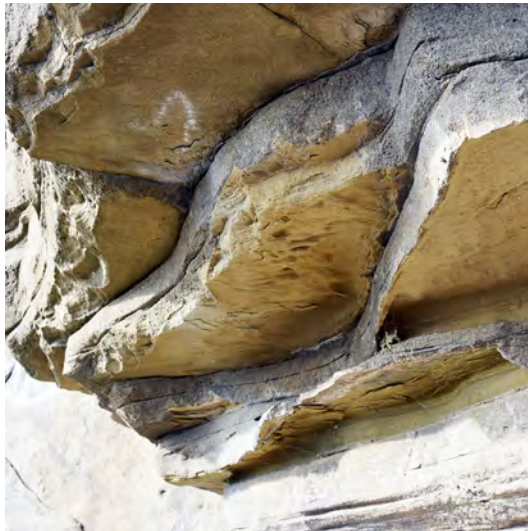
5.09: UNDERSIDE LOSS (B10)

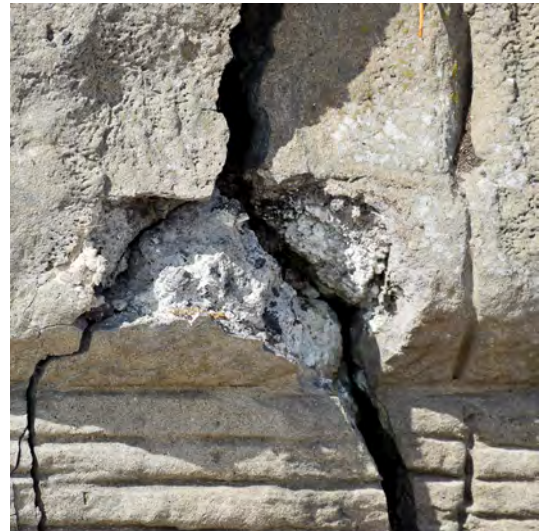
5.10: LOSS OF SURFACE AT FRACTURE (A32)

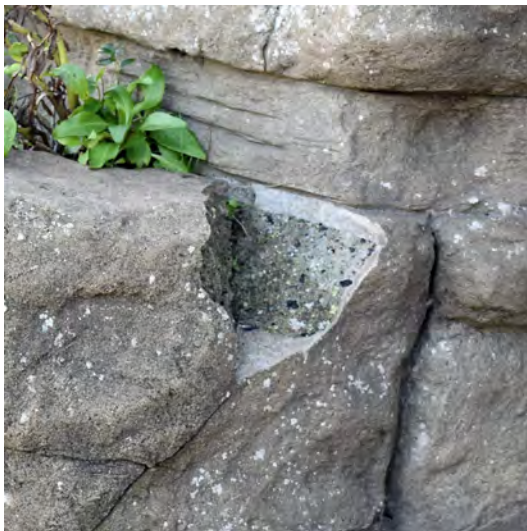
5.11: DEEP LOSS OF CONCRETE BACKING (C08) — POSSIBLY FROST DAMAGE.

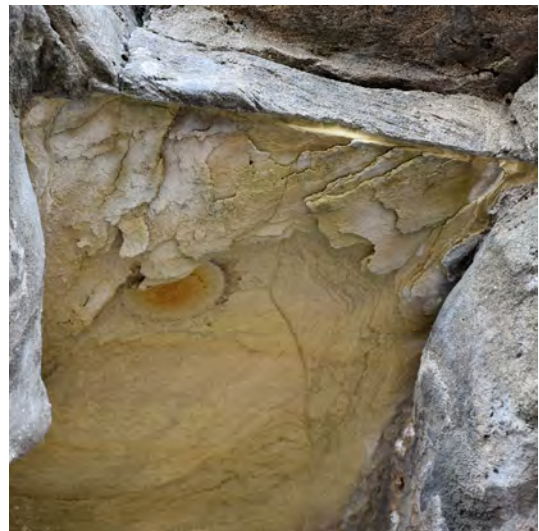
5.12: BREAK-DOWN & DELAMINATION OF STONE SLAB FORMING OVERHANG (B04B)

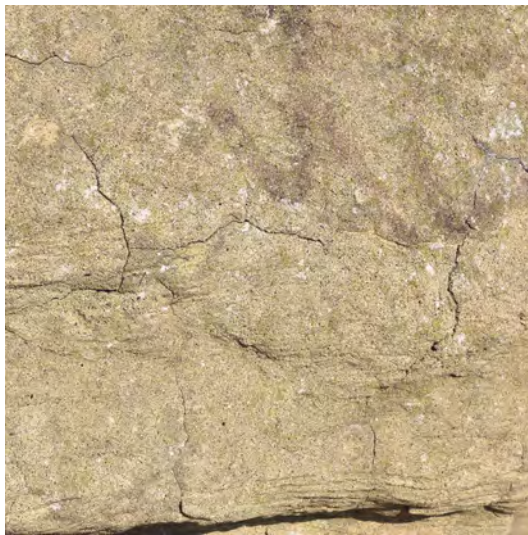
5.13: FINE SURFACE CRACKING (C12)

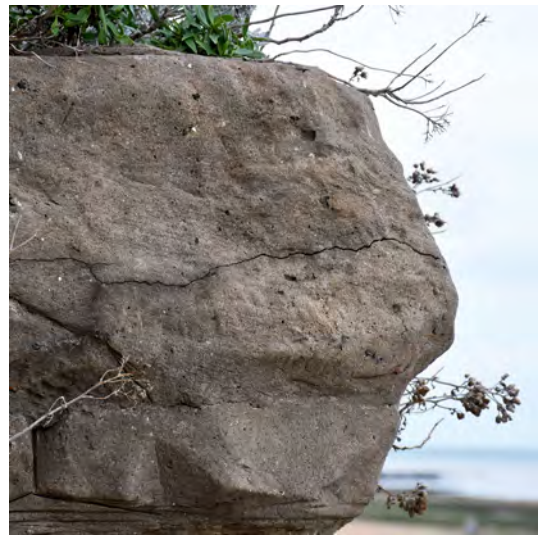
5.14: HAIRLINE FRACTURE (A11A)

- **Hairline fractures** can in the main be left and monitored albeit micro-grouting would be a good way of filling the widest (up to about 3 mm).

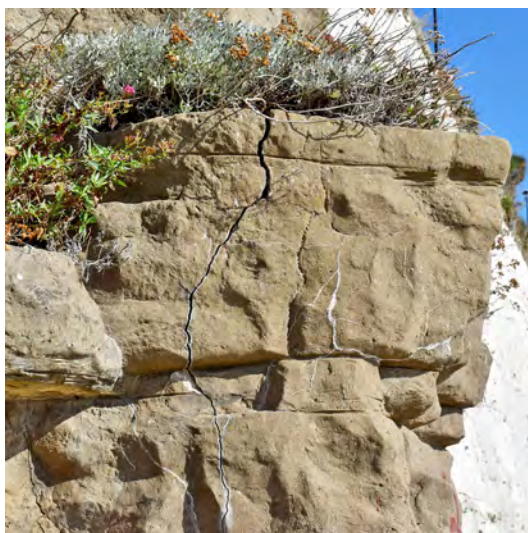
5.15: MAJOR FRACTURE (B22)

- Depending on width, **major fractures** should be repaired by grouting or filling with a weak, lime mortar. All filling should be set back so as to avoid the need to cut into and match otherwise sound surfaces. Maintaining the ‘shadow’ of the fracture will also ensure an ‘honest’ repair; a ‘matching’ repair would — by obscuring the fact that the repaired rockwork has a subtly different shape as compared to the original — distort the intention of the rock builders.
- Where fractures have led to wholesale **displacement**, the rockwork will need to be recorded, carefully taken down and rebuilt with original fabric eased back into position and where necessary surfaces skilfully repaired to match existing. Also the reinstatement of the detached plant pocket to B31, its salvaged fabric now resting within planting at the base of the middle face.

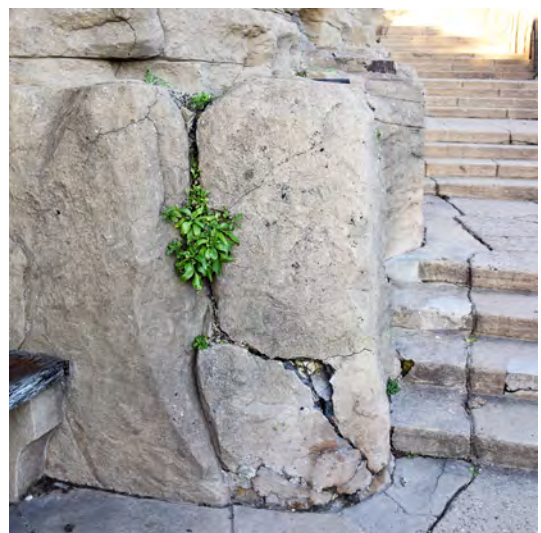
5.16: FRACTURE + DISPLACEMENT (C07)

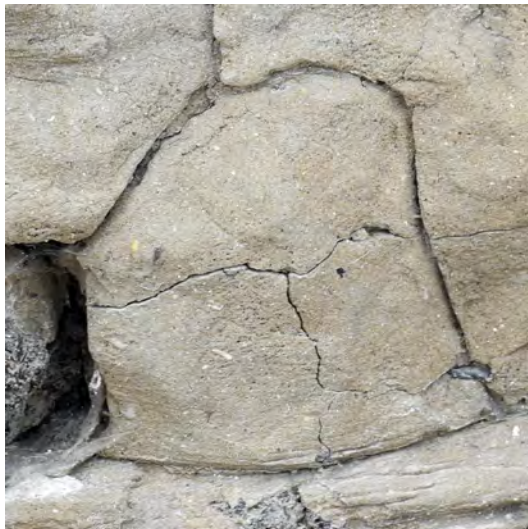
5.17: CRACKING — CHEMICAL AGENTS (A01)

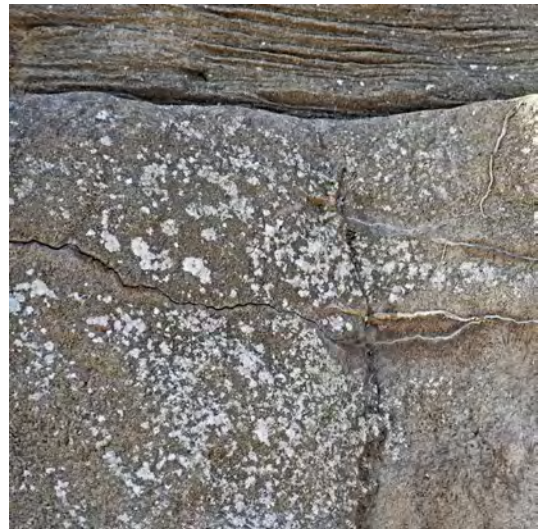
- 5.3.04 Given the close proximity of a large mass of chalk and hence calcium carbonate, white crystalline veins that align with mortar joints in the blockwork backing (especially towards the bottom of the lower face, above the fair-faced concrete block plinth) are most probably the mineral thaumasite, indicating as noted in 2.3.01 the use of modern OPC. Expanding crystals have resulted in cracking (refer also 5.5.03) that has broken-up the surface of the PAR and encouraged detachment. Frost action will also be a factor in underside loss; also the detachment of render adjacent fractures, albeit the differential movement of detached and dislodged portions of rockwork will be a contributory factor (refer 5.5.01, third bullet point).

5.18: CRYSTALLINE VEINS + CRACK (A05)

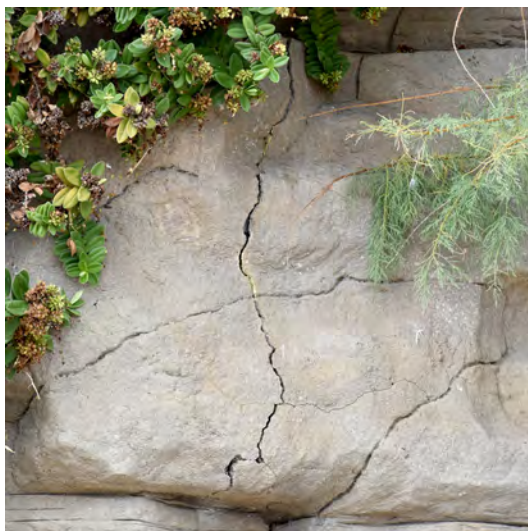
5.19: CRACKING DUE TO VEGETATION (A16)

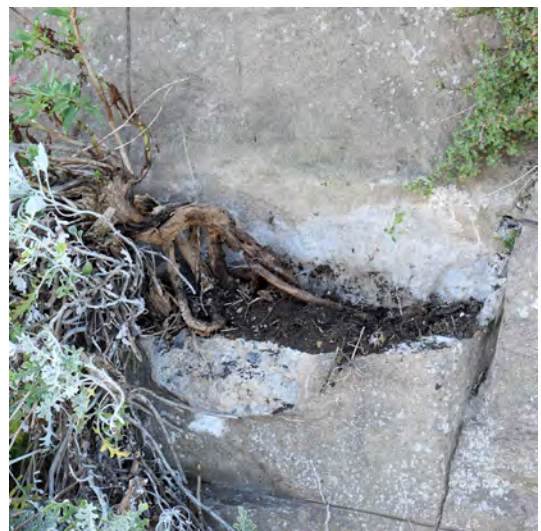
Fractures (B31) had resulted in a small plant pocket becoming dislodged, i.e. it was loose when touched. Since the Chine was at that time closed, the decision was taken — on the grounds of public safety — to deliberately topple and let fall a precariously balanced piece of PAR. Otherwise, no fractures seriously threatened the collapse of any other plant pockets or features, save there is some concern over the situation in A17, A18, (possibly) A19, and A32 & A34 immediately above (refer 5.5.04).

5.20: FAILURE DUE TO ROOT DAMAGE (B31)

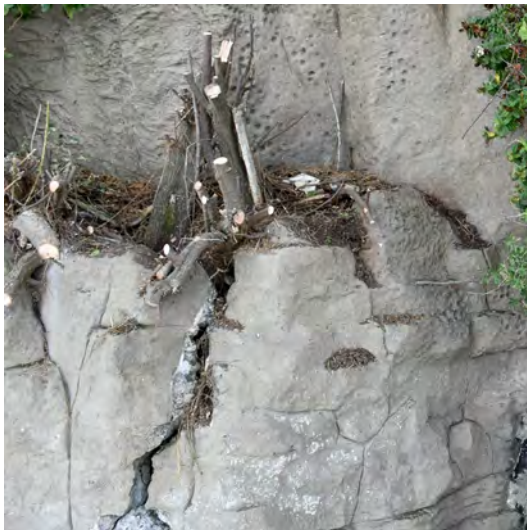
5.21: FRACTURE OF PLANT POCKET (A32)

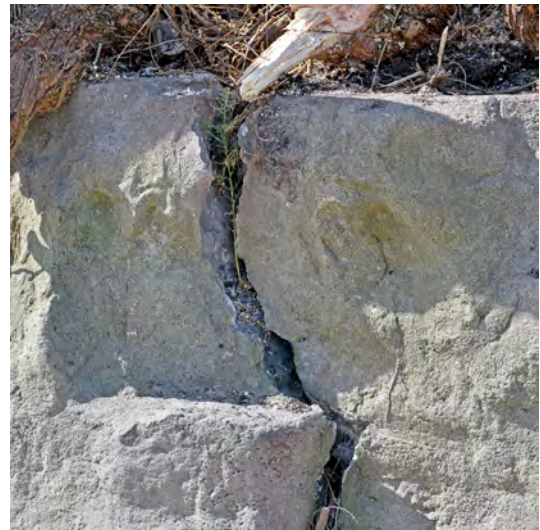
5.22: FRACTURE + DISPLACEMENT (A34)

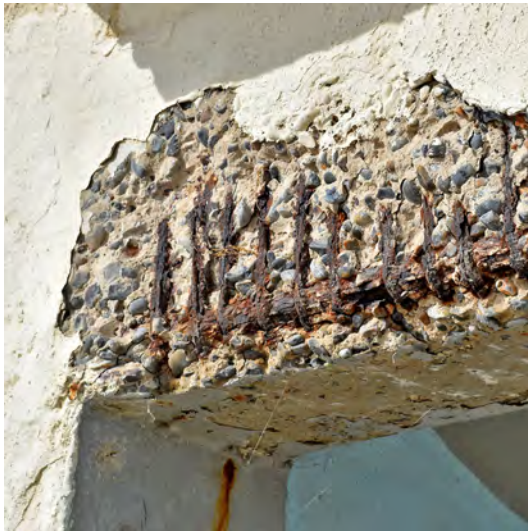
5.23: CONCRETE TO SHELTER (A05)

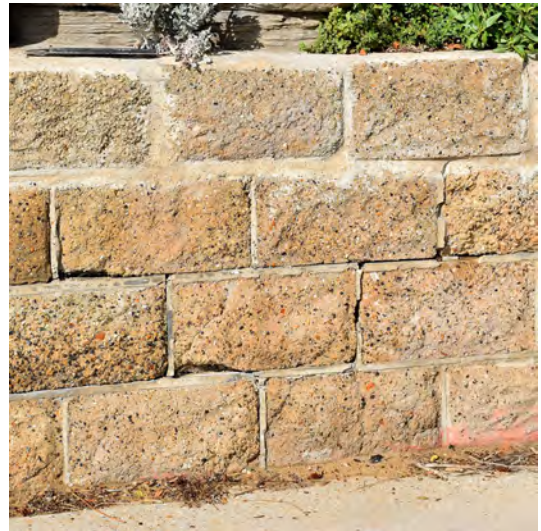
5.24: FAILED CEMENT POINTING (A06)

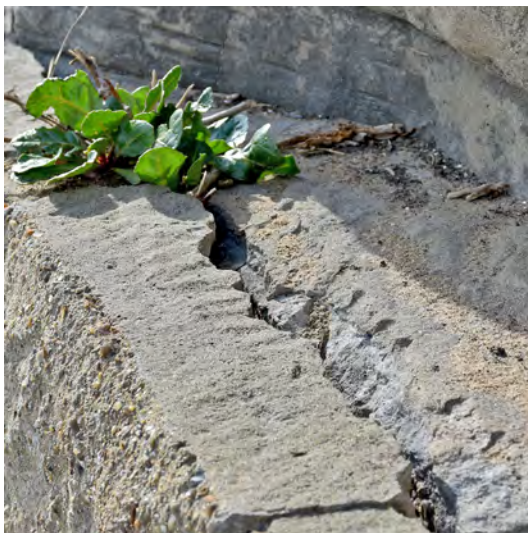
5.25: OPEN JOINT TO BLOCK PLINTH (A08)

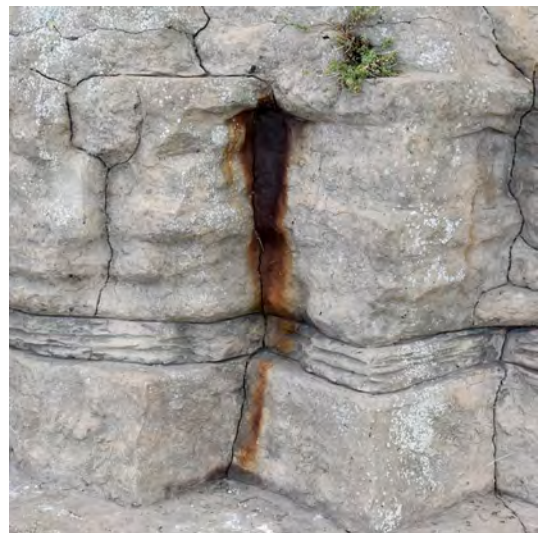
5.26: INTENSIVE METAL STAINING (A23)
