Conservation of  
**PULHAMITE ARTIFICIAL ROCKWORK**  
Ramsgate, Kent

**MADEIRA WALK**  
**STAGE TWO REPORT**

**Ramsgate Heritage Action Zone  
(HAZ) Partnership**

June 2020

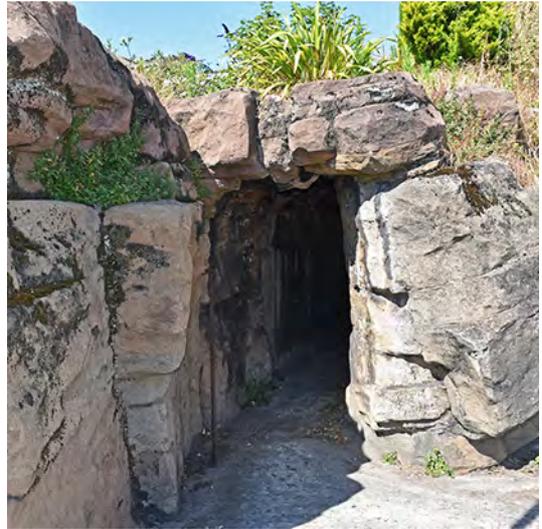
2.30: PASSAGEWAY TO REAR OF OAK HOTEL

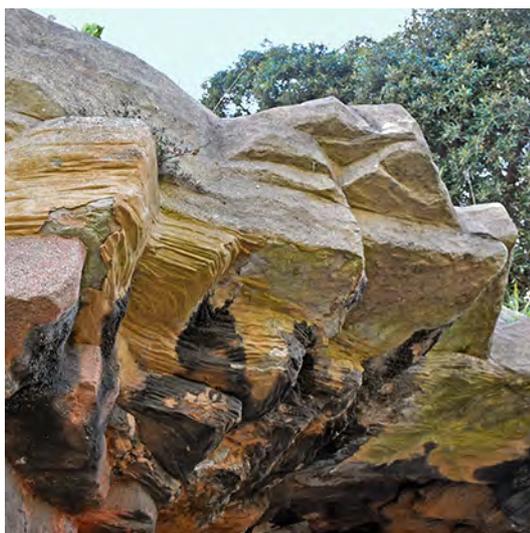
2.35: CANTILEVERED STONE SLABS CORBEL  
TO FORM ROOF OF TUNNEL

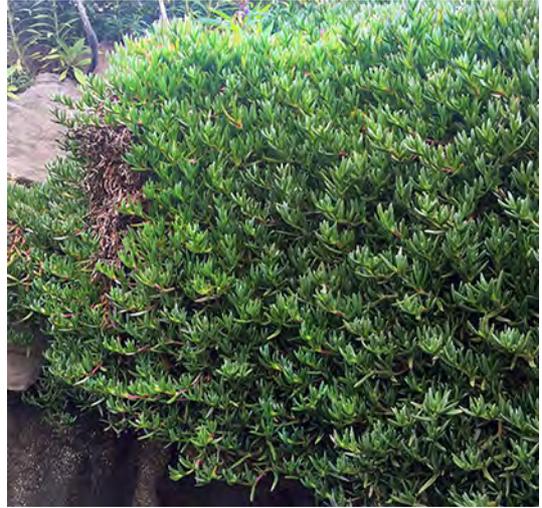
3.1.02 Most of LUC plant types are evident at Madeira Walk, along with a large array of additional plants, notably a large number of *Phormium cultivars*, *Valeriana officinalis* and *Photinia sp.* Common red and Californian poppies are present as well as grasses (including pampas) and bamboos. *Carpobrotus rossii* is creeping rapaciously over some rock faces and there are many herbaceous, annually-planted, half hardy plants at lower level (some appear on the LUC lists). Many plants have 'self seeded' and some are invasive and possibly damaging, e.g. *Quercus ilex* (Holm oak), Sycamore seedlings (*Acer pseudoplatanus*) and *Pyracantha sp.*, especially where rooted in small plant pockets that leave little room for expansion.

3.03: CARPOBROTUS ROSSII

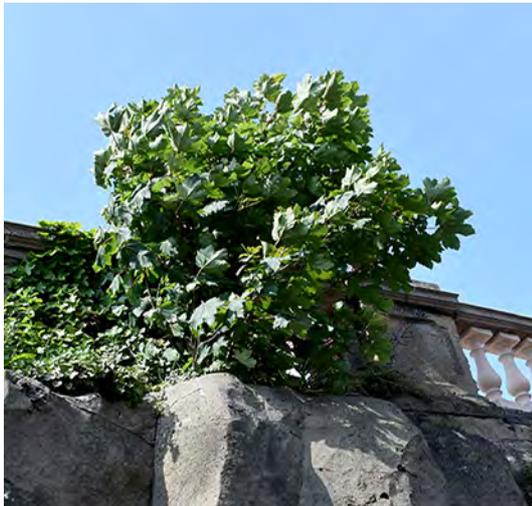
3.04: SYCAMORE SEEDLING

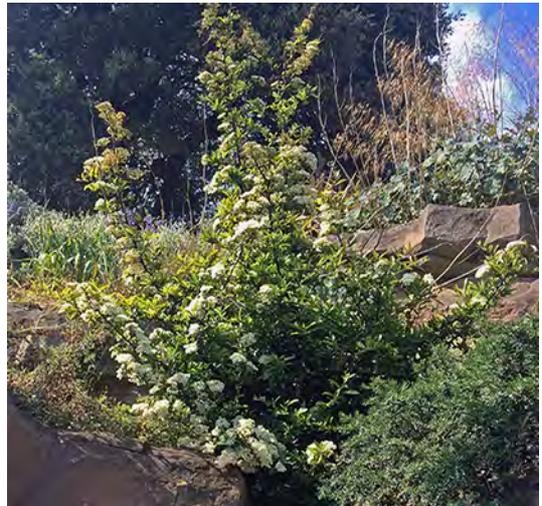
3.05: PYRACANTHA

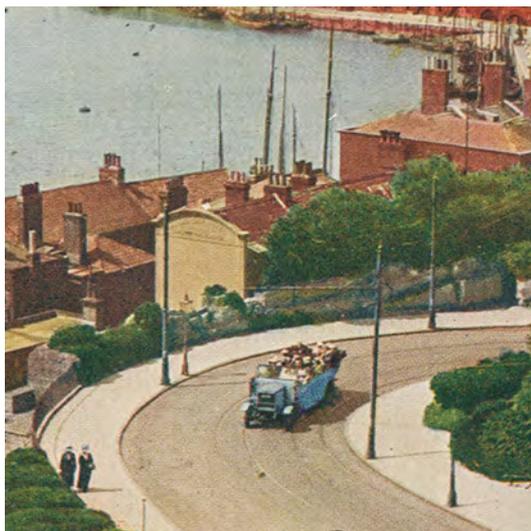
4.11: EXTRACT FROM POSTCARD c.1920  
SHOWING PAR DEMOLISHED IN 1990

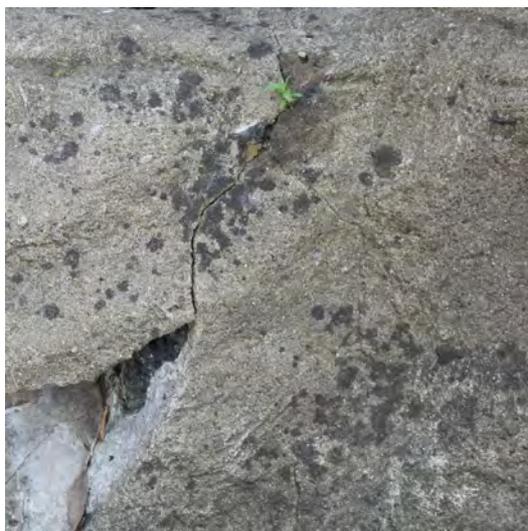
5.02: AIRBORNE DIRT + LICHENS (S02)

- 5.2.04 Soiling and discolouration of the Madeira rockwork is a minor issue and, other than where cleaning might be needed as part of any repair, there is no need for cleaning, notwithstanding graffiti control being an essential part of routine maintenance (refer 6.3.06 & 6.3.07). Nonetheless, mosses indicate damp and hence should be removed to enable the condition of the rockwork below to be examined.

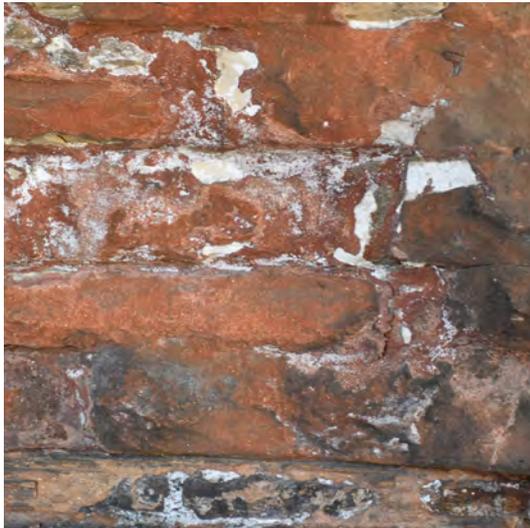
5.03: SURFACE EFFLORESCENCE (S08B)

the first stage of this process. While the crusts (which are almost certainly ‘cross-liked’ with the render coating and hence hard to remove) and blooms may eventually play a role in surface erosion, they are in the main benign and should be accepted as part of the historic aging of the rockwork. The only exception would be where cleaning is necessary to effect repairs, noting that within the grotto recesses, tunnel and passage airborne dirt and sulfation can be difficult to distinguish.

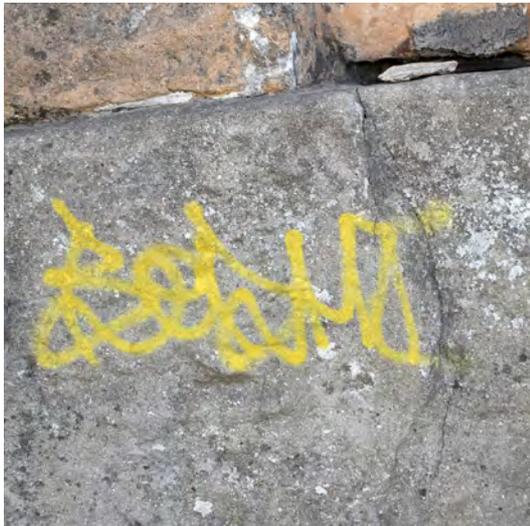
- **Graffiti** was light and mainly comprised chalk though relatively fresh aerosol paint was in once case noted (S04); minor instances of faded paint and thicker spots were also observed (N13, N15A, N15B, N16, N35, S07 & S08B). NO PARKING is painted onto the PAR retaining wall to the south of Madeira Walk (refer 2.2.05).

5.05: GRAFFITI — SPRAY PAINT (S04)

- 5.2.03 Given that graffiti removal (refer D3.08 of Appendix D) can itself be highly damaging, the few instances of paint are best left to continue to fade, especially as they are not obtrusive or offensive. The only exception might be the relatively fresh graffiti to the rear of S04. Chalk is also best left. If rubbed too early it can permanently stain (especially if on top of other forms of soiling) and will eventually wash away, albeit light sponging may be employed in sheltered areas.

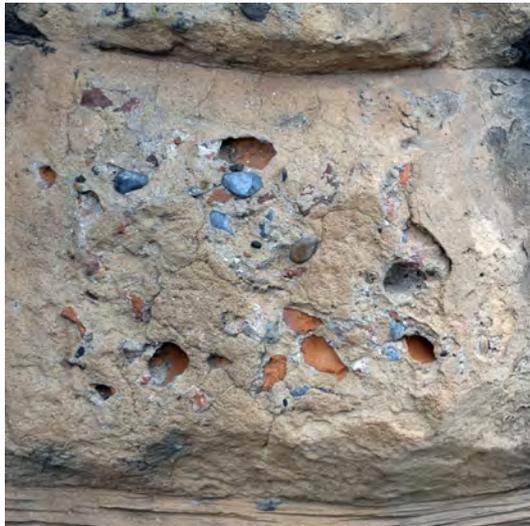
- Areas of more intensive pitting mixed with hollowness and granulation leading to areas of total surface loss and exposure of the backing (rough brick and concrete) were noted in zones N09, N11 and N18. Complete loss of surface was also observed in zones S01, S02, S04, S05, S08C, S09, S10 and S11.

5.09: PITTING &amp; HOLLOWNESS (N09)

- 5.3.03 Two of the observed instances of more widespread pitting, hollowness, granulation and surface loss (N09 & N11) appear to relate to orientation as well as salt build-up having reached the point where the render coating has been weakened by chemical action (refer 7.3.03/05 of the Overview: Stage One Report). Here, the light-coloured PAR — which is low down and hence relatively sheltered, i.e. not washed, similar to if it were beneath and overhang — faces the Harbour and hence is exposed to a prevailing wind that is laden with high levels of salt (sea spray) as well as fine grains of sand whipped-up from nearby beaches. Salt levels and abrasion will therefore be intensified making detached or friable surfaces more prone to erosion and loss. Hence the ‘preferential’ weathering.

- 5.3.07 Renewal and restoration of the hollowed, granulated and lost areas of surface as considered in 5.3.03 and 5.3.05 is also a possibility. However, as regards N09 and N11, the high exposure to salts and southwest orientation — key agents of decay — cannot be changed, the deterioration would in time be repeated; likewise the sometimes deteriorated chalk block backing to S01, S02, etc. In which context it would be prudent to continue to monitor and — in line with the philosophy set out in 5.1.03 — accept localised surface loss as part of the historic ‘weathering’ of the PAR, subject to review as part of the next quinquennial (five-yearly) survey update.

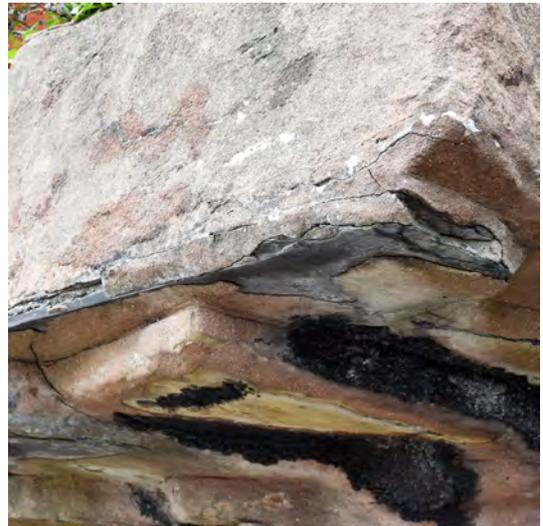
5.10: UNDERSIDE LOSS (N16)

- 5.3.05 Salts will also have exacerbated the loss of surface from the undersides of overhangs, albeit decay is slightly less prevalent in the top tier of plant pockets which — being ‘one-sided’ and part of the ground — have more capacity to carry water away from the vulnerable stone and slate cantilevers (refer 7.3.05 of the Overview: Stage One Report). It should be noted that horizontal hairline fractures are the first sign of underside loss (refer 5.5.03). Frost action will also be a factor in underside loss as well as the detachment of render adjacent fractures, albeit differential movement or settlement (of detached and dislodged portions of rockwork) might in such cases be a contributory factor).

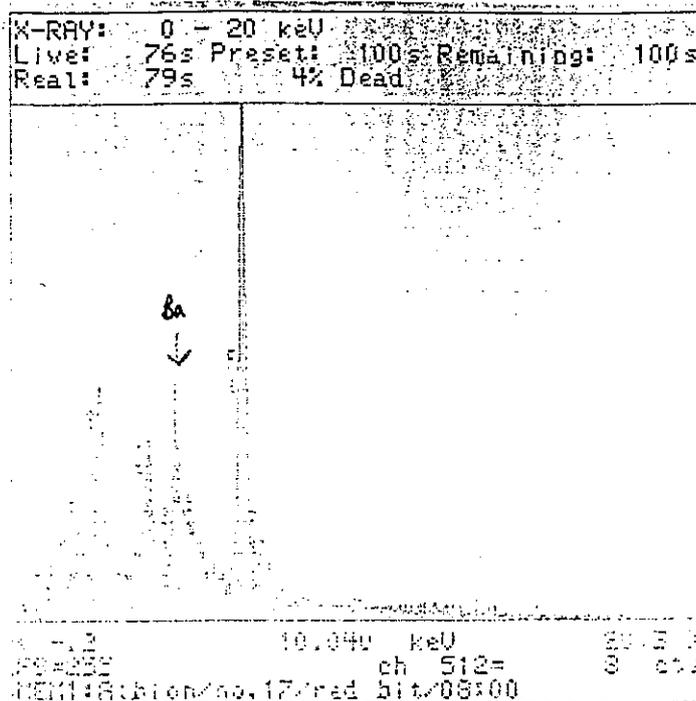
### SEM ANALYSIS of a red lump

The major element is iron  
There is also calcium and sulphur  
from sulphated lime, and barium  
from barium sulphate

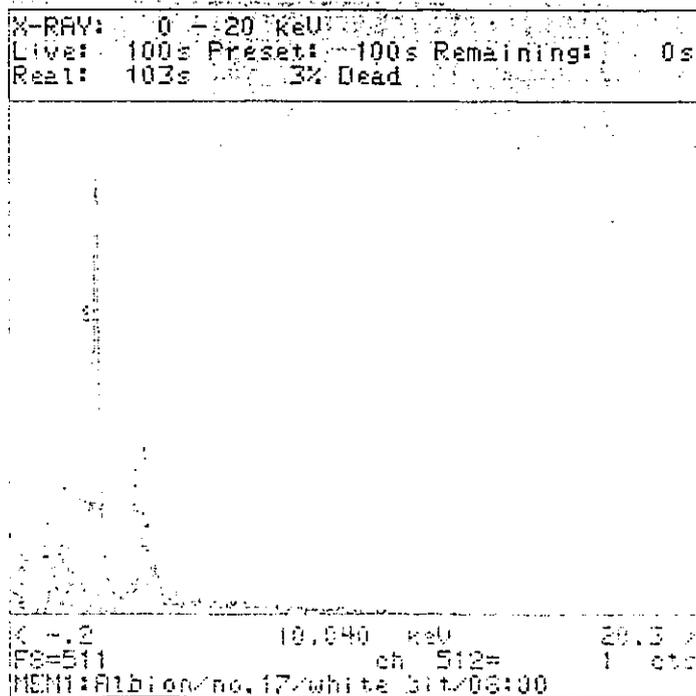
### SEM ANALYSIS of a white lump.

There is some calcium, but  
the major element is  
sulphur. This is the reverse  
of what is found in the  
general mixture [see next  
page]

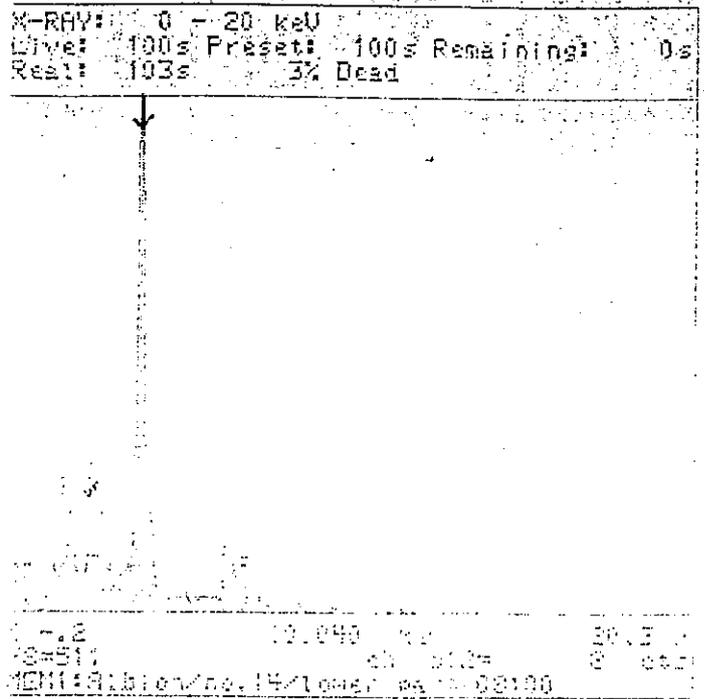
**SEM ANALYSIS of the lower part of section 14.**

Calcium is the major presence. Its ratio to sulphur is about 6:1

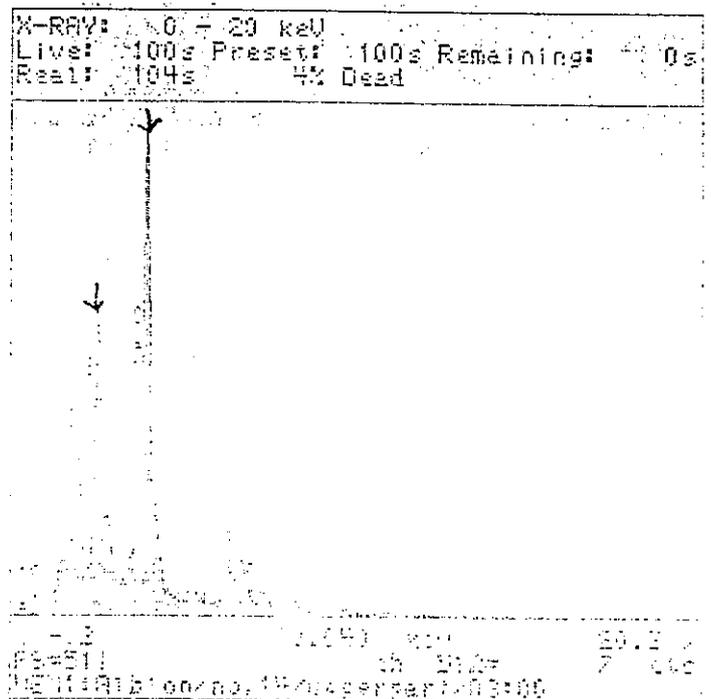
**SEM ANALYSIS of the upper part of section 14**

Comparing this spectrum with the one from deeper in the sample, we can see that although calcium is still the major element, its ratio to sulphur is about 3:2

It suggests that calcium in some form has been leached out of the surface layers of the mortar.
