Conservation of  
**PULHAMITE ARTIFICIAL ROCKWORK**  
Ramsgate, Kent

**WINTERSTOKE GARDENS**  
**STAGE TWO REPORT**

**Ramsgate Heritage Action Zone  
(HAZ) Partnership**

June 2020

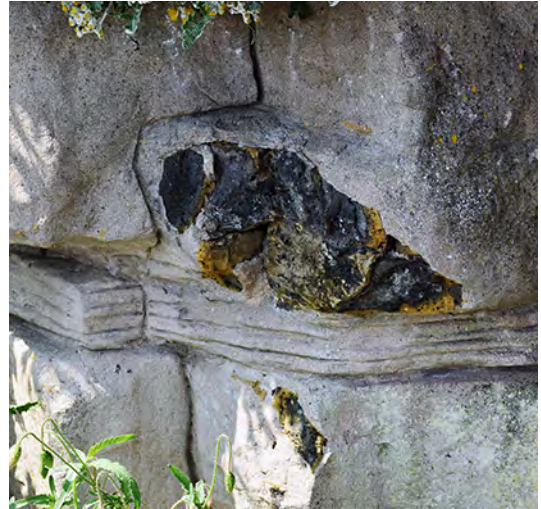
2.16: BRICKS AT BASE OF PLANT POCKET

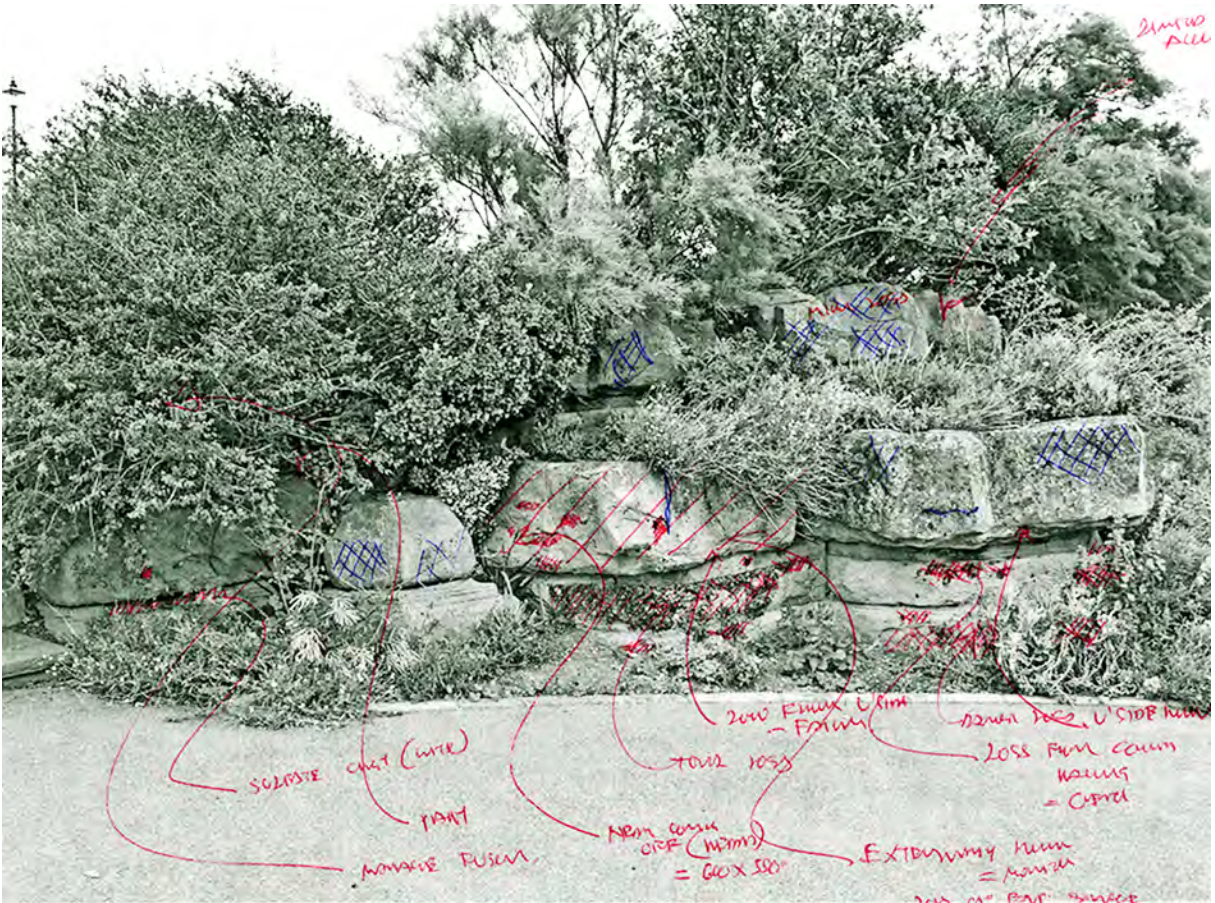
BASE SURVEY PHOTO (TOP) & MARKED-UP COPY (BOTTOM)
