Conservation of
PULHAMITE ARTIFICIAL ROCKWORK
Ramsgate, Kent

EAST CLIFF CHINE
STAGE TWO REPORT

**Ramsgate Heritage Action Zone
(HAZ) Partnership**

June 2020

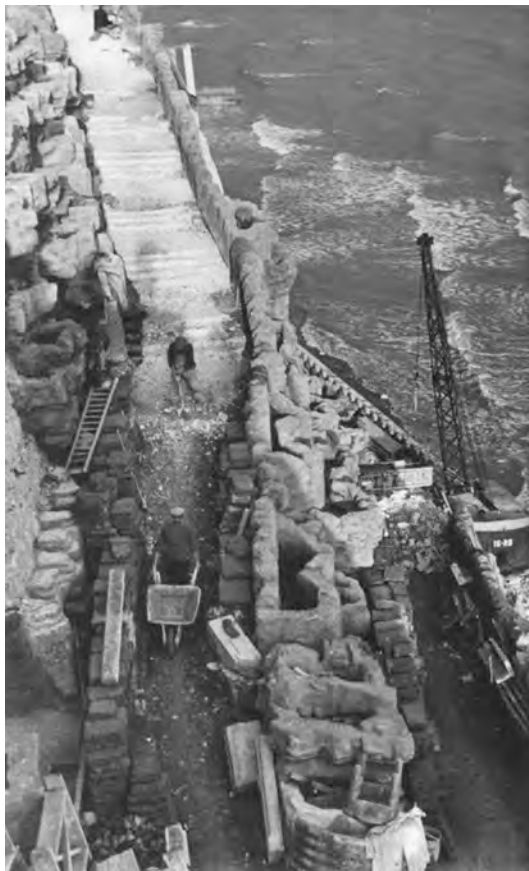
4.01: UNDER CONSTRUCTION 1936
(NOTE CHUTE NEAR CENTRE RIGHT)

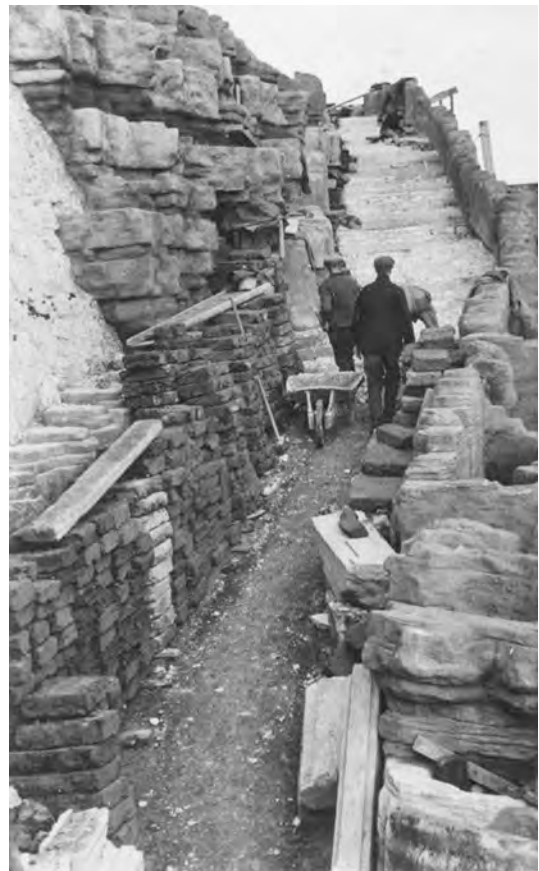
4.02: UNDER CONSTRUCTION 1936
(NOTE CONCRETE BLOCK BACKING)

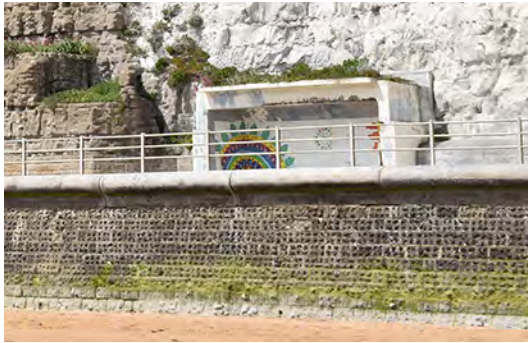
4.03: FLINT-FACED SEA WALL & CONCRETE SHELTER

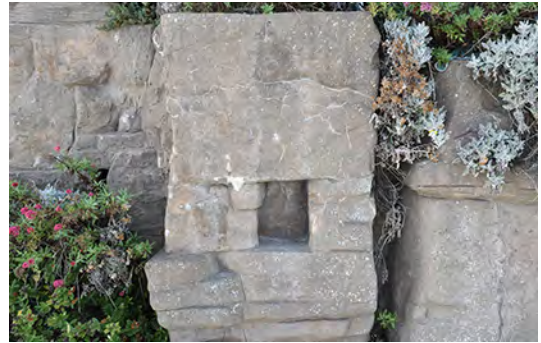
4.04: ASSUMED EXIT OF CHUTE FOR DELIVERY OF CONCRETE

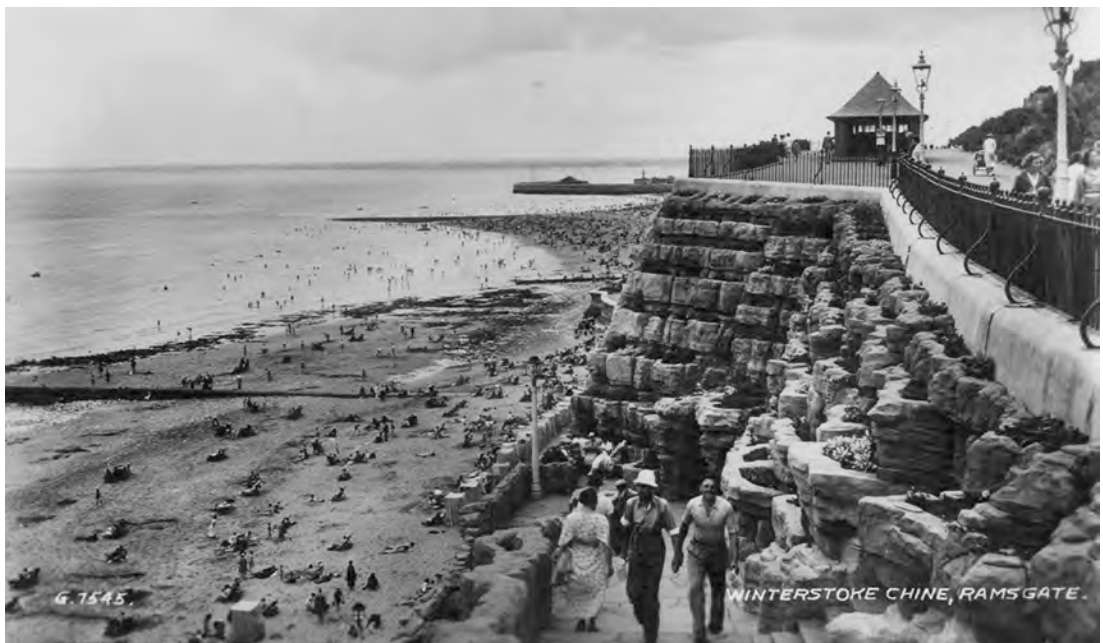
4.08: EAST CLIFF CHINE SOON AFTER OPENING (NOTE LACK OF PLANTING)

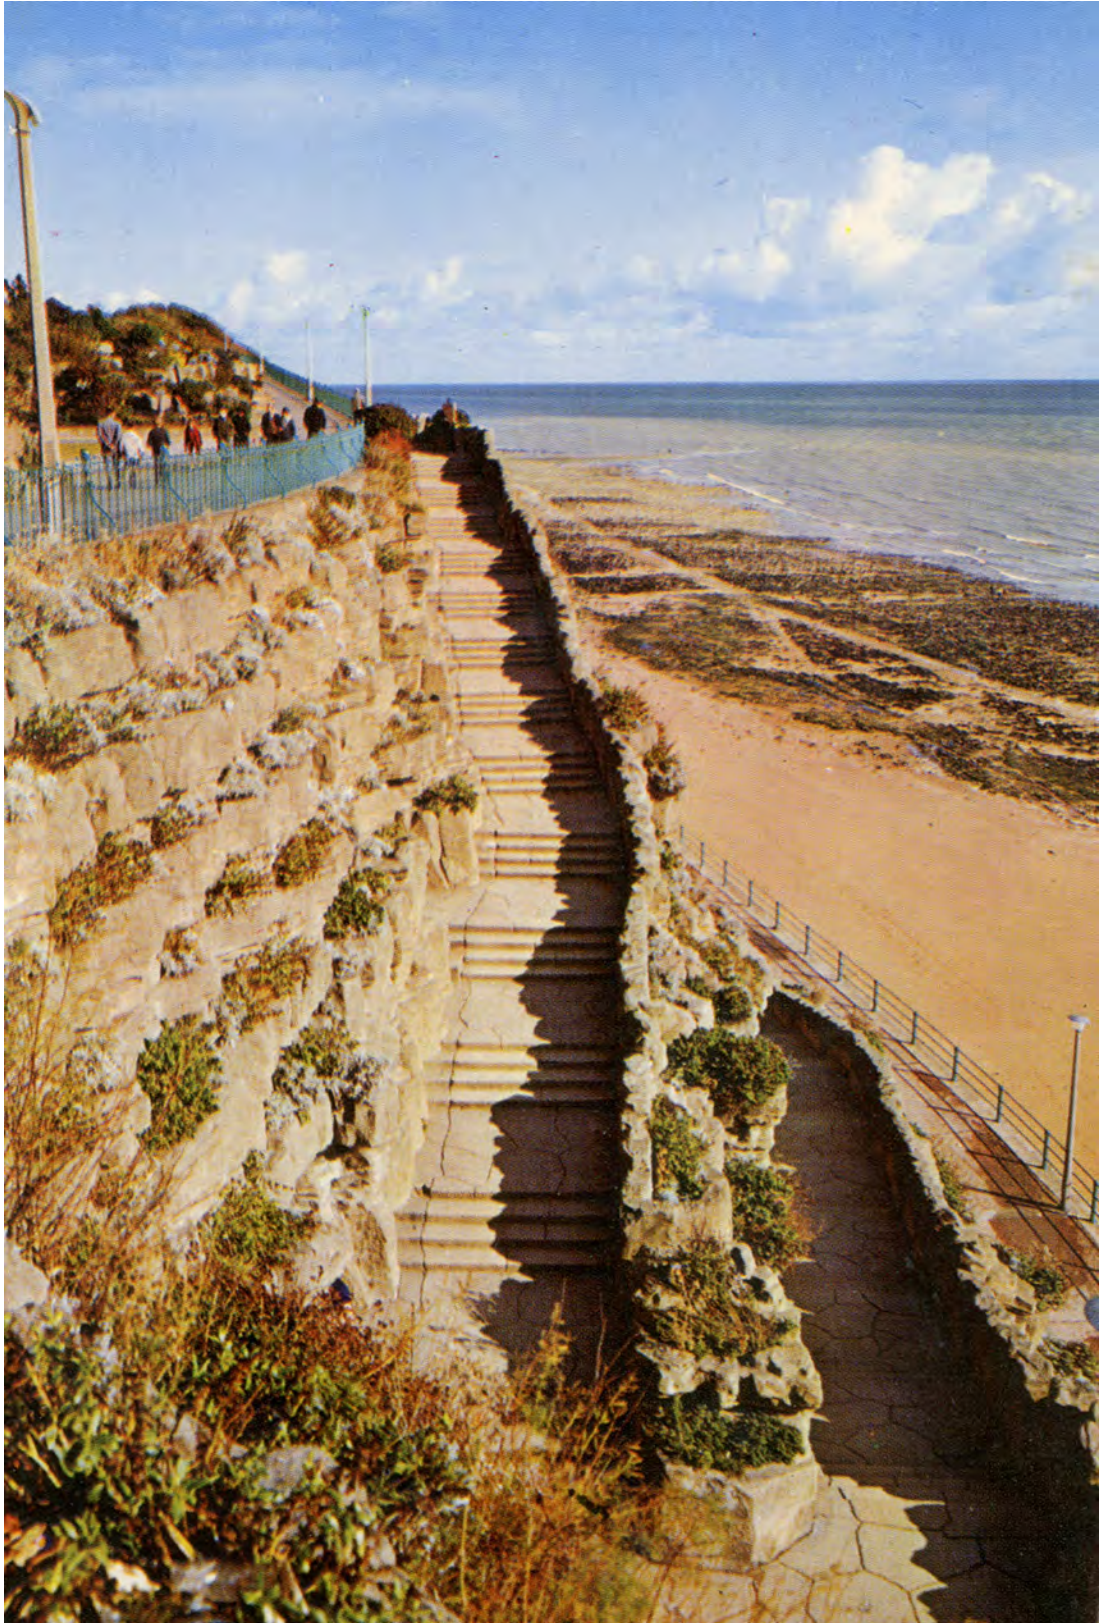
4.09: LOOKING DOWN ONTO TOP FLIGHT OF THE CHINE SHOWING ROWS OF PLANTERS
(ASSUMED — ON BASIS OF CONCRETE LAMP POST — 1950s or 1960s)
