Conservation of  
**PULHAMITE ARTIFICIAL ROCKWORK**  
Ramsgate, Kent

**WINTERSTOKE GARDENS**  
**STAGE TWO REPORT**

**Ramsgate Heritage Action Zone  
(HAZ) Partnership**

June 2020

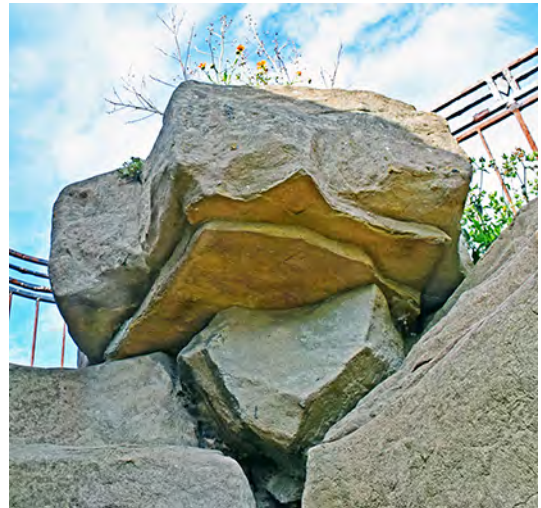
2.18: STONE SLAB OVERHANG

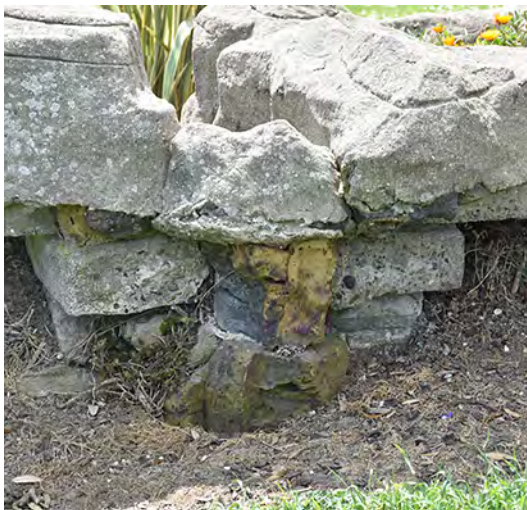
2.19: EXPOSED STRUCTURE OF OUTCROP

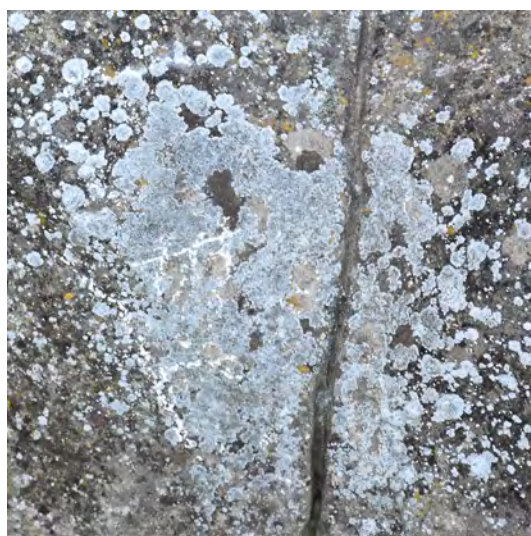
5.01: TYPICAL LICHEN GROWTH

- 5.2.02 Instances of mosses notwithstanding; lichens and the relative lack of airborne dirt are indicative of the good condition of the PAR coating generally, the result of it being removed from busy roads and historically polluted urban areas, along with a high degree of exposure to driving rain. i.e. rain washing.

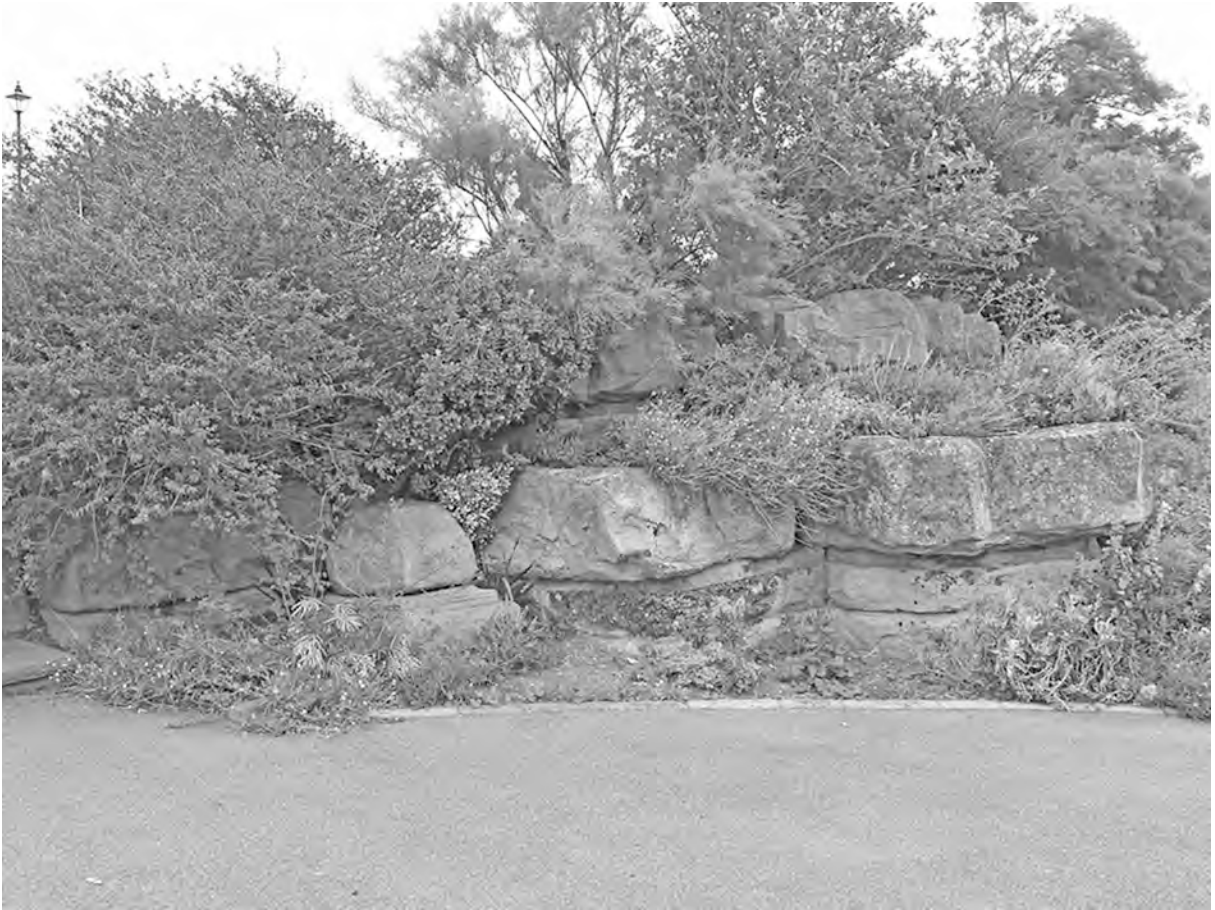
BASE SURVEY PHOTO (TOP) & MARKED-UP COPY (BOTTOM)
