Conservation of
PULHAMITE ARTIFICIAL ROCKWORK
Ramsgate, Kent

EAST CLIFF CHINE
STAGE TWO REPORT

**Ramsgate Heritage Action Zone
(HAZ) Partnership**

June 2020

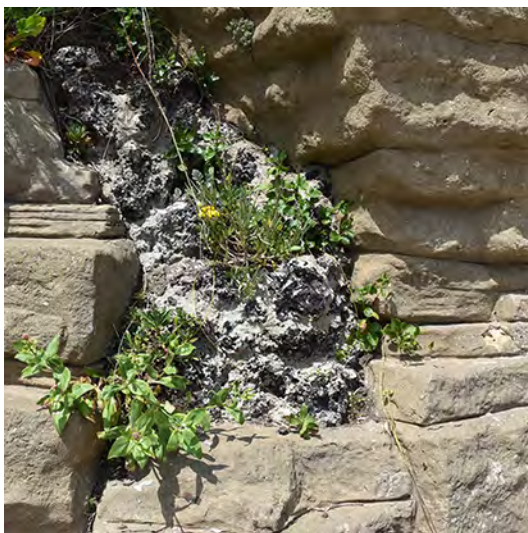
2.25: BURRS PACKED INTO FISSUE

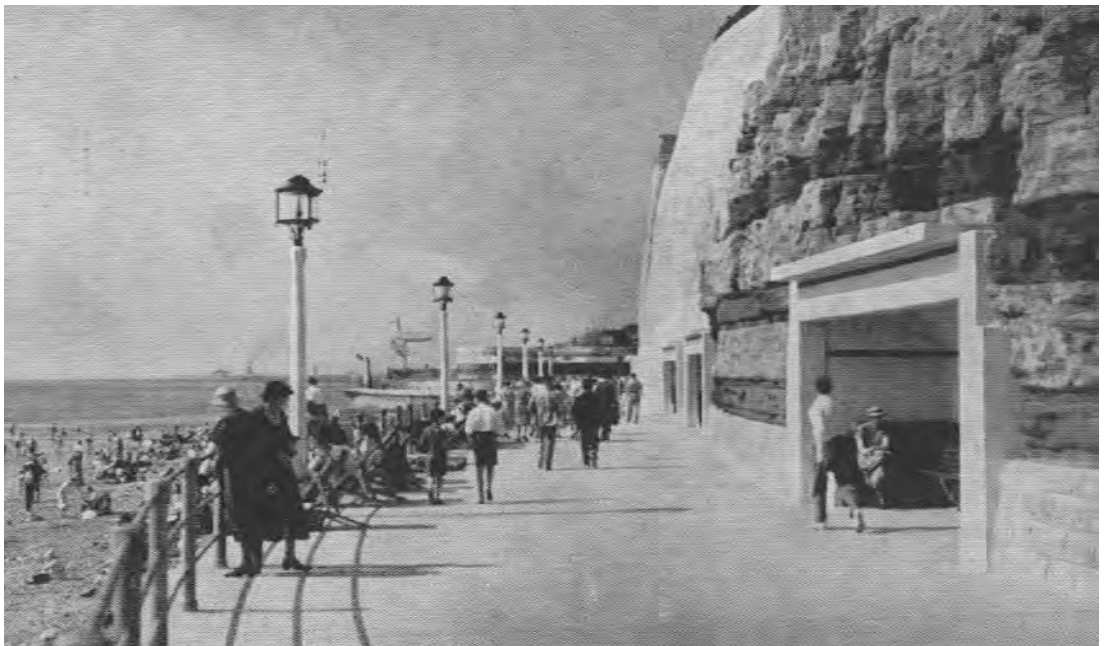
4.05: UNDERCLIFF PROMENADE PRE WW2 (COURTESY MICHAEL'S BOOKSHOP)

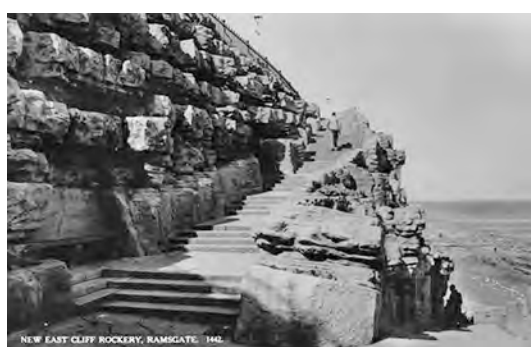
4.10: UPPER FLIGHT OF CHINE c.1936
(COURTESY MICHAEL'S BOOKSHOP)

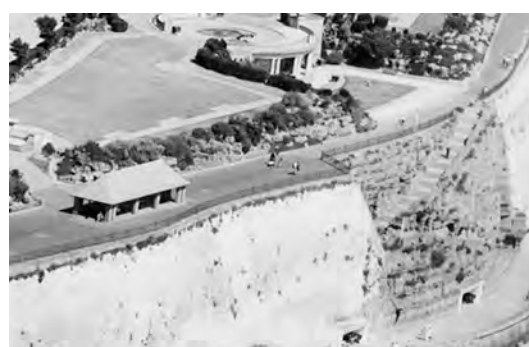
4.11: AIR VIEW OF CHINE (RIGHT) IN 1947
(EXTRACT BFA ref. EAW009013)

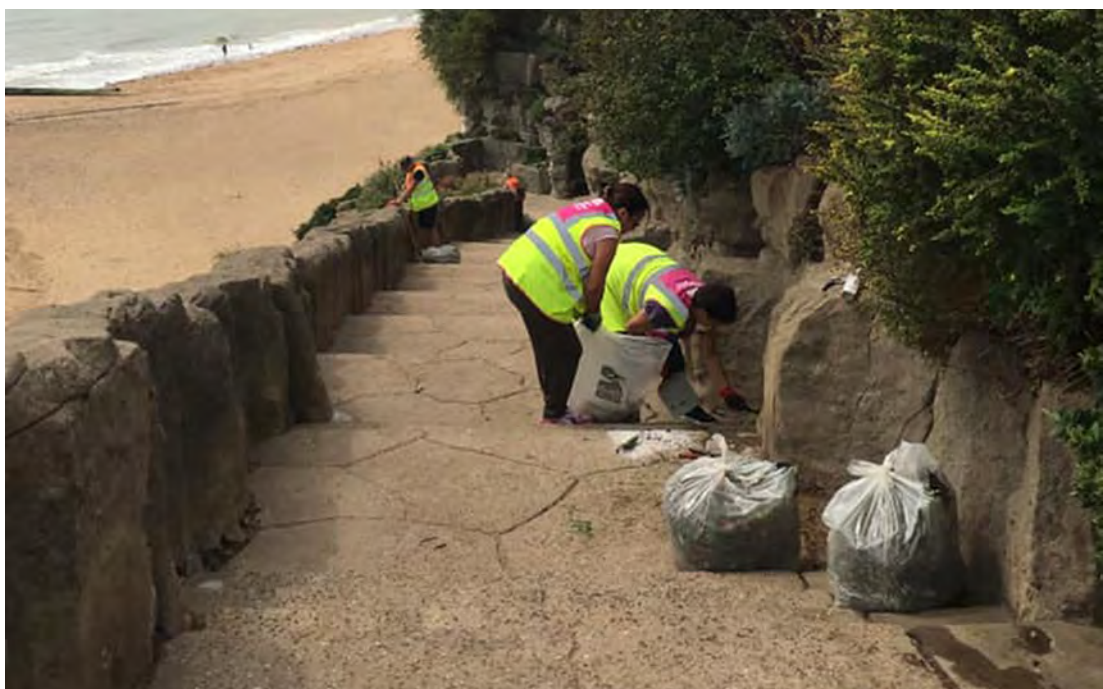
6.01: VOLUNTEERS MAINTAINING THE PLANTING OF THE EAST CLIFF CHINE

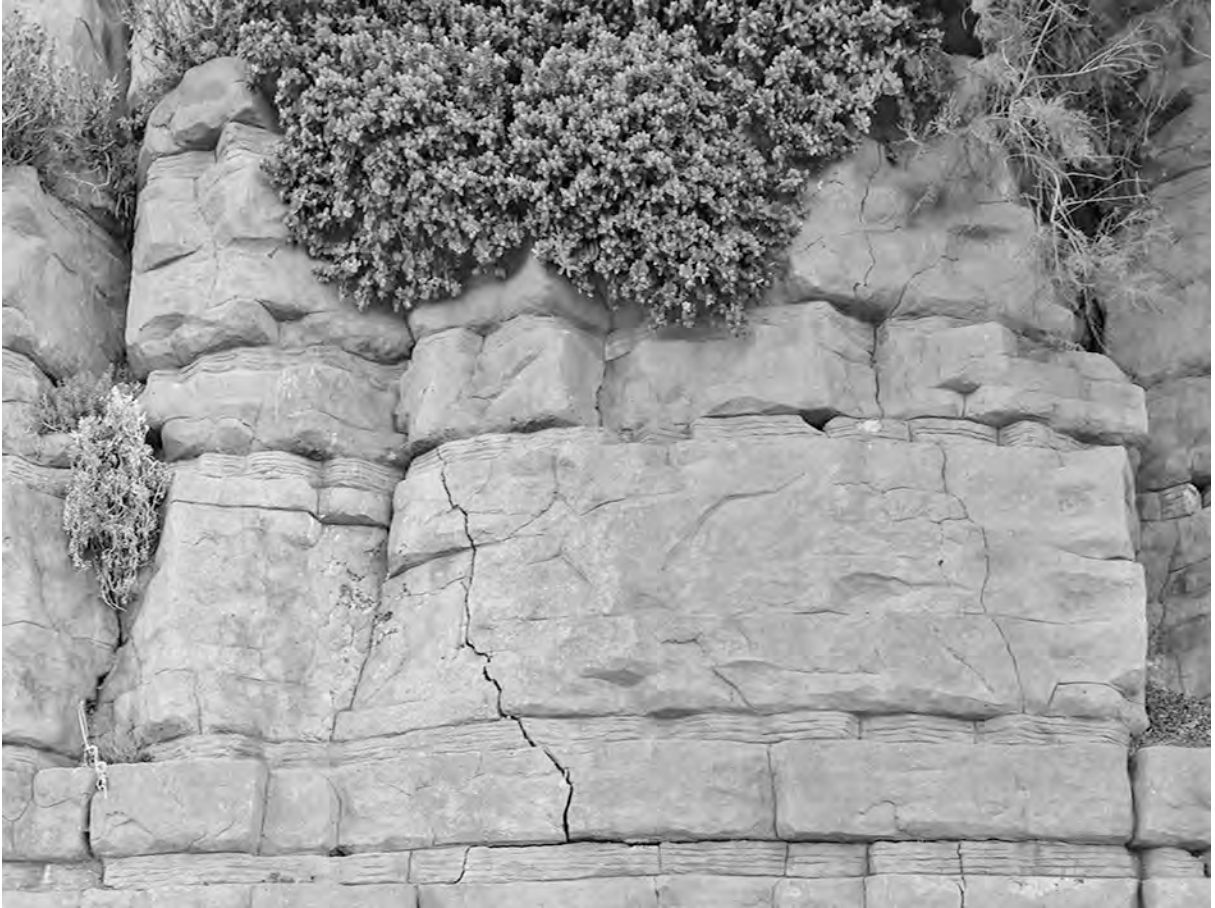
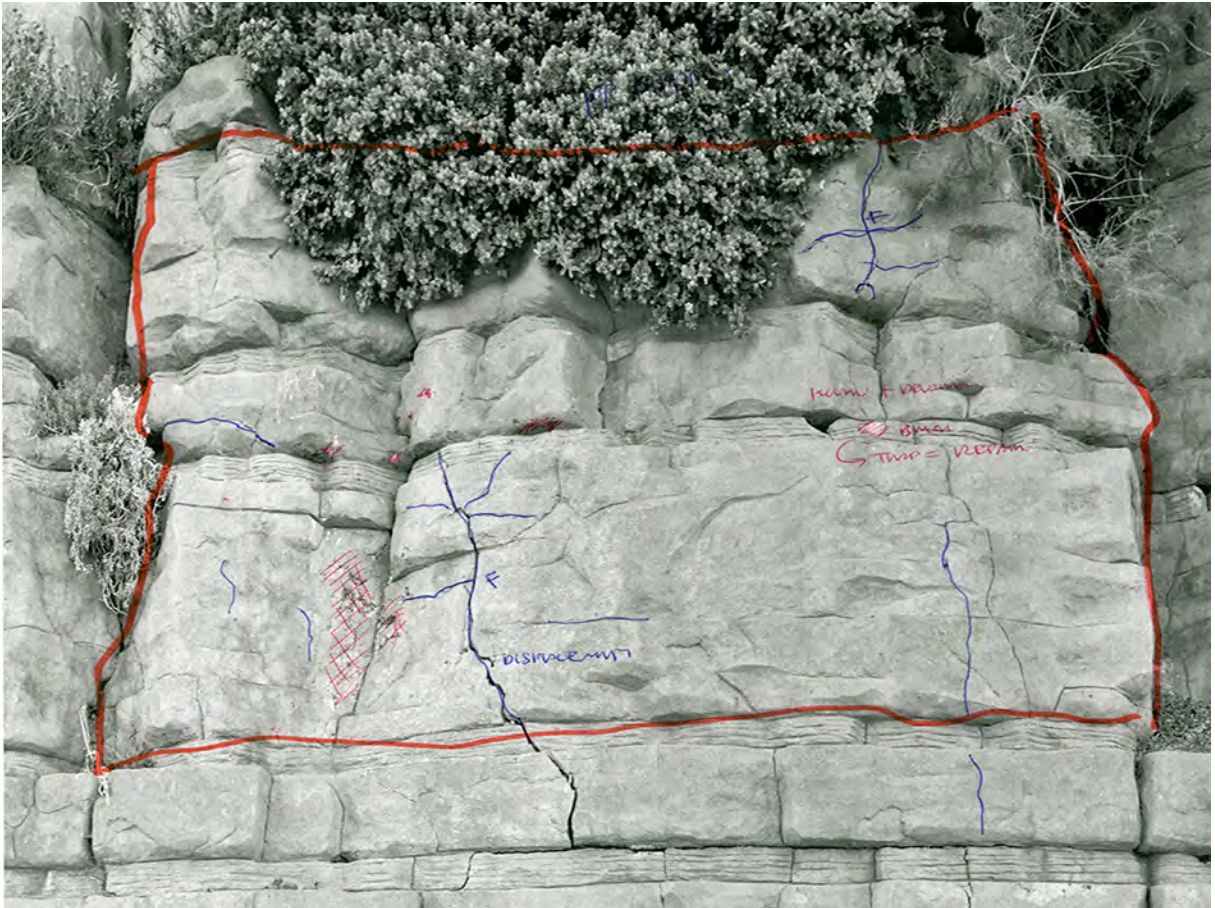
BASE SURVEY PHOTO (TOP) & MARKED-UP COPY (BOTTOM)
